# **Stage 1/2 Road Safety Audit Caltragh LRD, Caltragh, Co. Sligo**

**Stage 1/2 Road Safety Audit**  
**Caltragh LRD, Caltragh, Co. Sligo**

<b>Client:</b>	John Walter Burke
<b>Document No:</b>	231304-ORS-XX-XX-RP-TR-13g-001

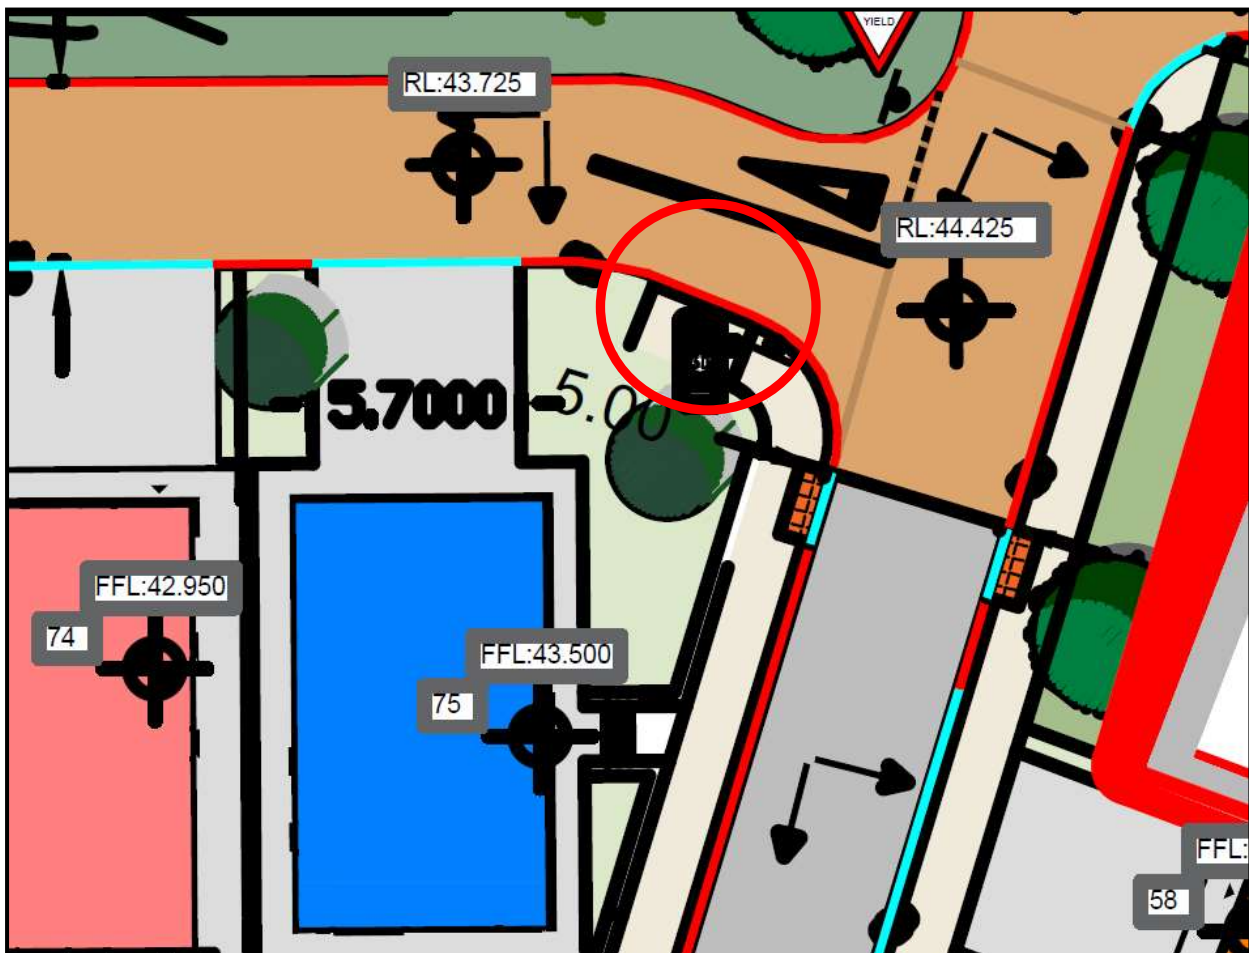
##### Problem No.1: Footpath Termination at Homezone at Unit 75

##### Location: Tie in of Footpaths with Homezone Area

The audit team note that there is no dropped kerb or tactile at the identified location that will also users to safely negotiate between the footpath area and the homezone area. This could create a safety risk for visually impaired users and mobility impaired users in particular who may be unaware that they are entering into an area that is shared with vehicles.

The design team should ensure that advanced warning such as tactile paving and dropped provided where footpaths tie into homezone areas.

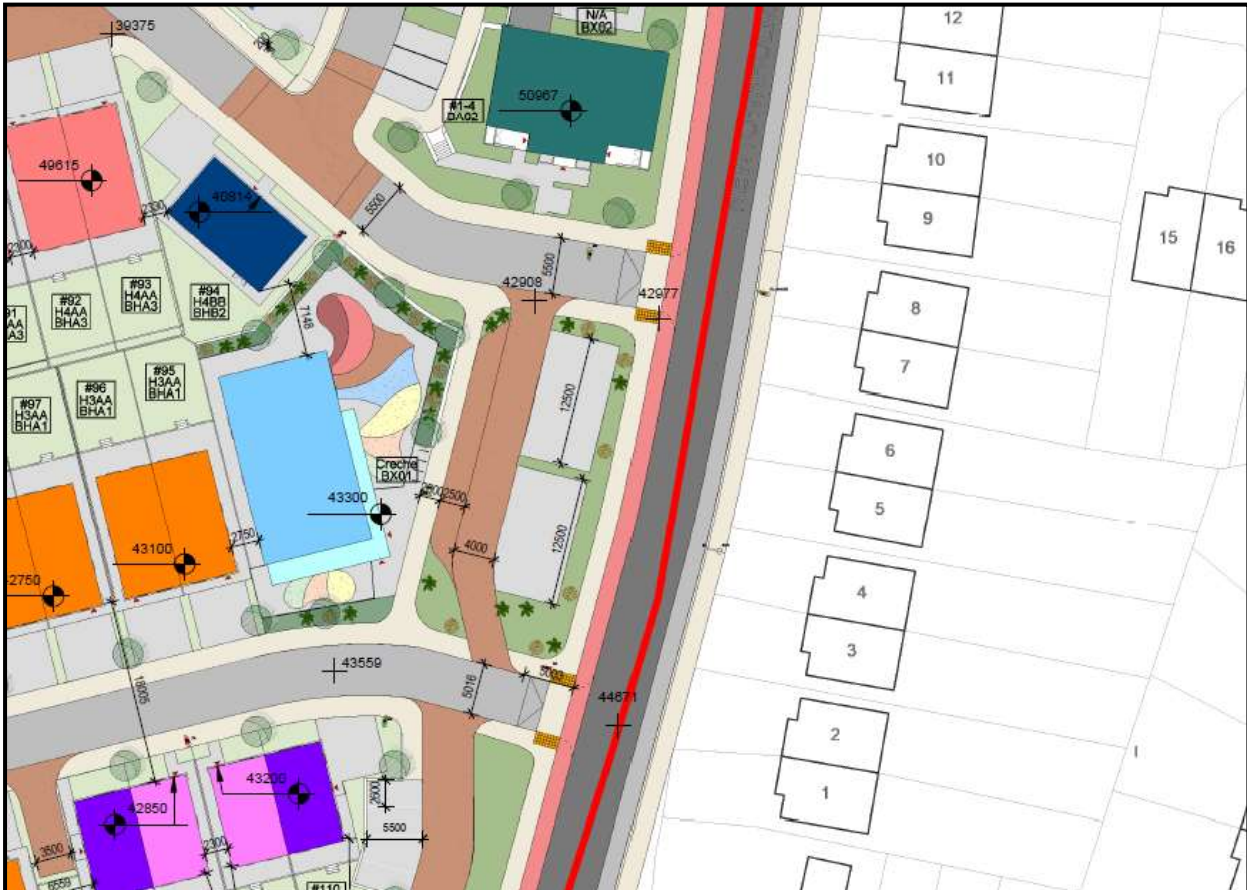
## Problem No.2: Two Number Main Accesses in Close Proximity

### Location: Entrance to Development

The audit team note that it is intended to provide two main access into the development which is located in close proximity to one another. The audit team are concerned that an additional access point creates additional conflict points for all users and increases the likelihood of potential conflicts among all users.

The design team should remove one of the access points to reduce the safety risk identified.

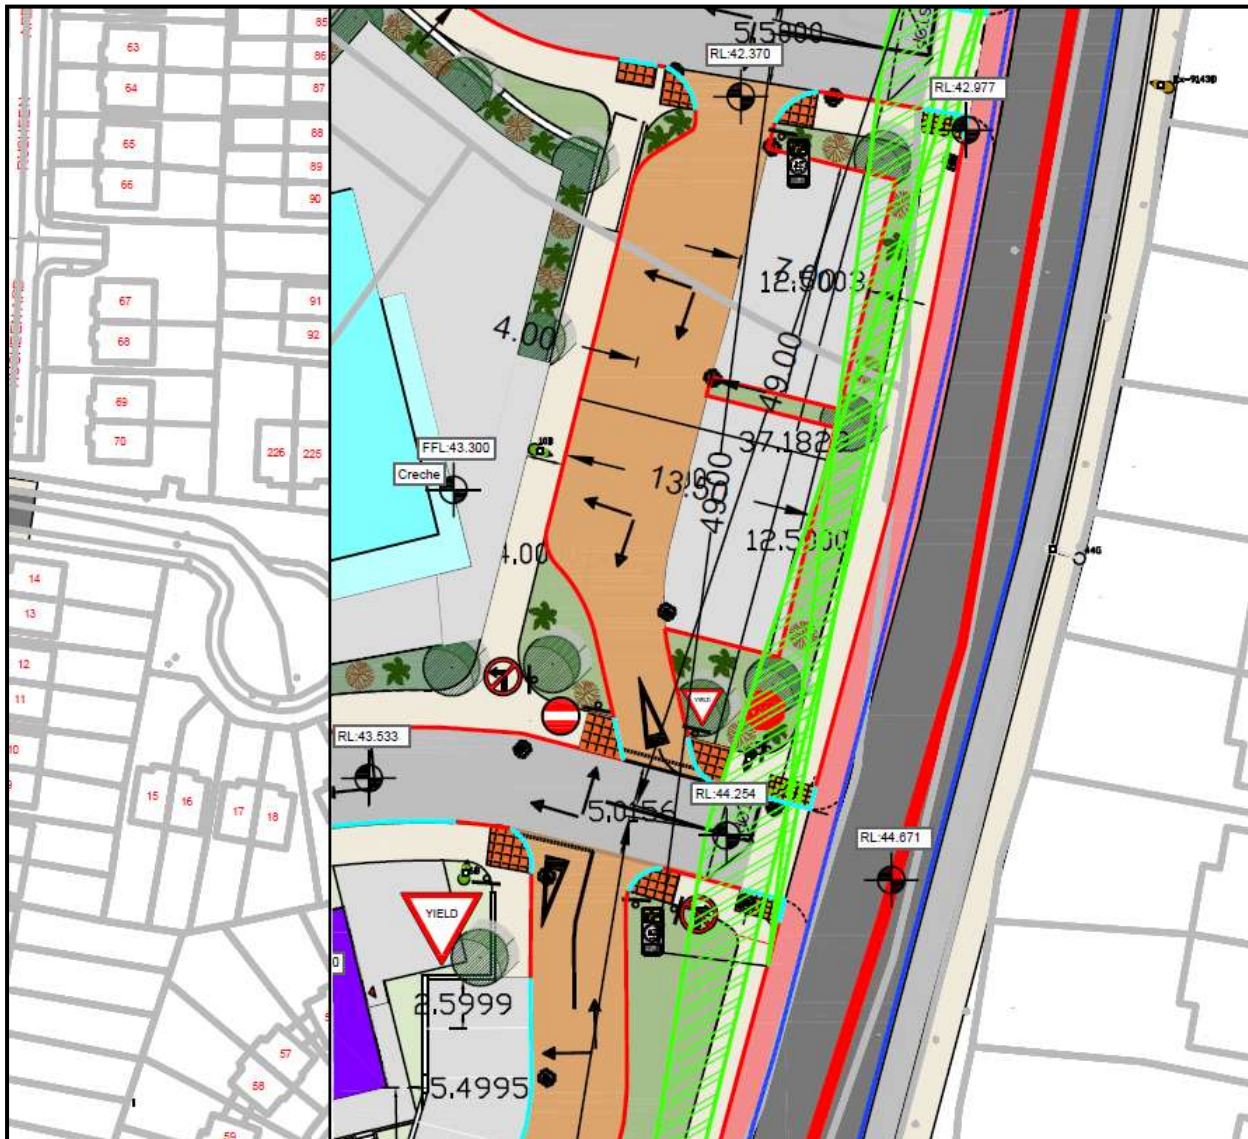
## Problem No.3: Sightlines

### Location: Main Access Junctions

The audit team note that visibility splays at the main access points are shown through landscaped areas which will restrict sightlines considerably. Inadequate sightlines and stopping sight distances could lead to sideswipe, side impact or rear end shunt type collisions resulting in injury to vehicle occupants.

The design team should ensure that sightlines are not restricted by existing or proposed landscaping or street furniture to ensure full unrestricted visibility at the junctions in accordance with appropriate design standards.

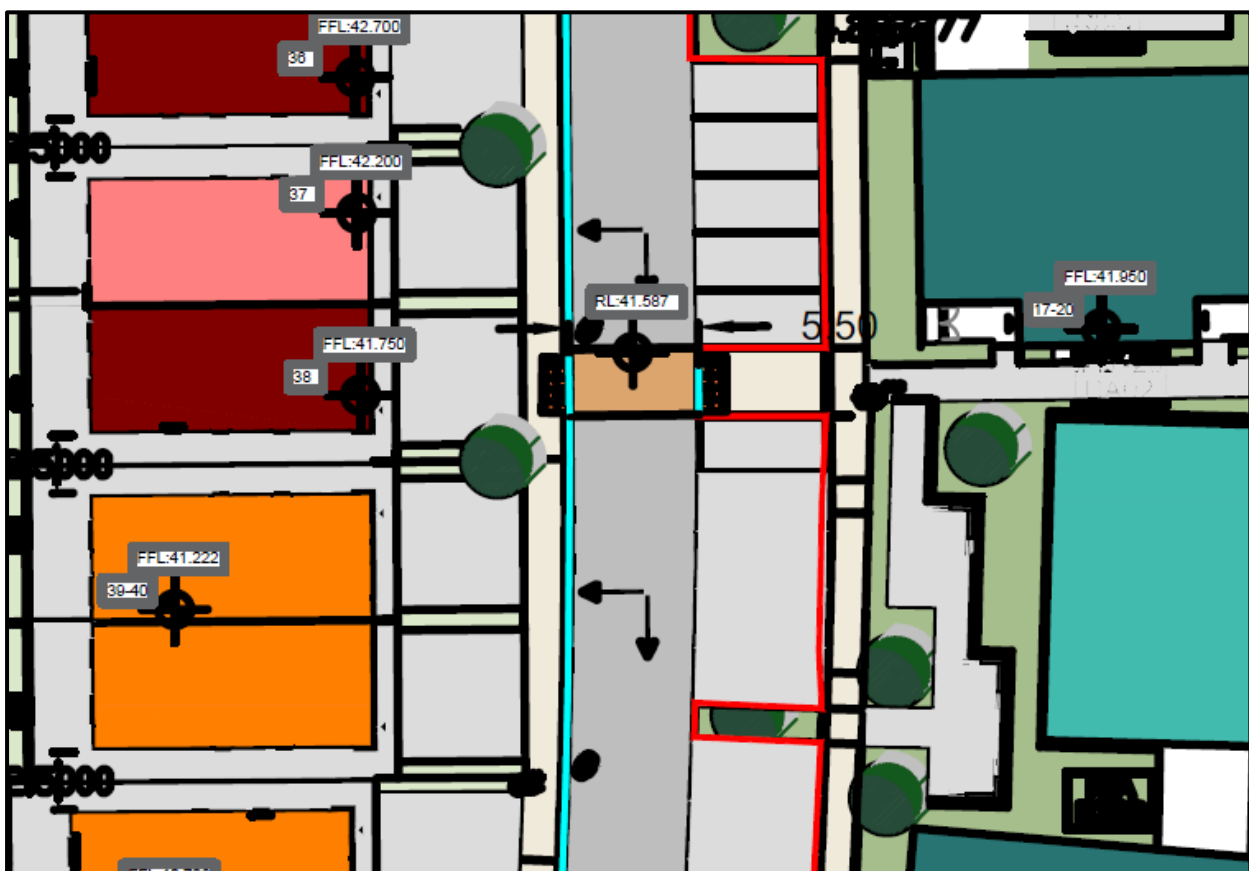
## Problem No.4: Speed Control Measures

### Location: Throughout Scheme

The audit team note from the drawings provided, that there does not appear to be speed control measures proposed within the scheme, particularly along straight stretches of roadway. The audit team are concerned that the long section of straight roads within the scheme could encourage higher speeds which could put vulnerable users within the development at risk. Should a collision occur there is a high risk of injury to the vulnerable user. The audit team note that there is a pedestrian crossing within these long stretches which are at grade with the proposed carriageways which increases the risk further.

The design team should ensure that appropriate speed control measures are incorporated within the development to reduced vehicular speeds.

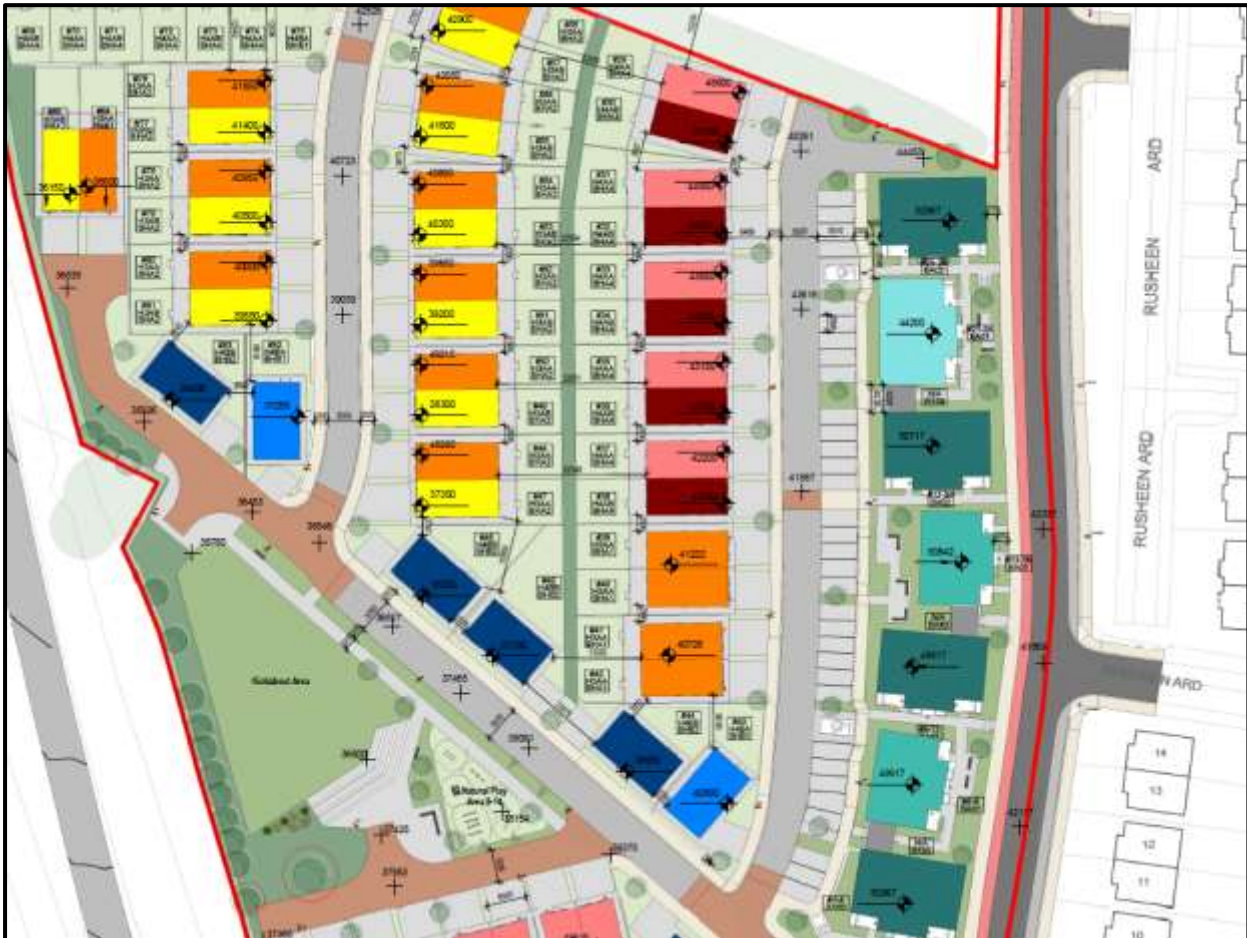
## Problem No.5: Pedestrian Permeability

### Location: Internal Site Layout

The audit team note from the drawings provided, that there are no details relating to the proposed footpath and kerb levels at entrances throughout the development. Inadequate use of footpath and kerb specifications may lead to undulating or uneven surfaces along the pedestrian paths, resulting in slips, trips and falls and injury for pedestrian with limited mobility.

The design team should consider including the use of bevelled edge kerbs at vehicle accesses along the footpath to allow for level pedestrian paths throughout the site.

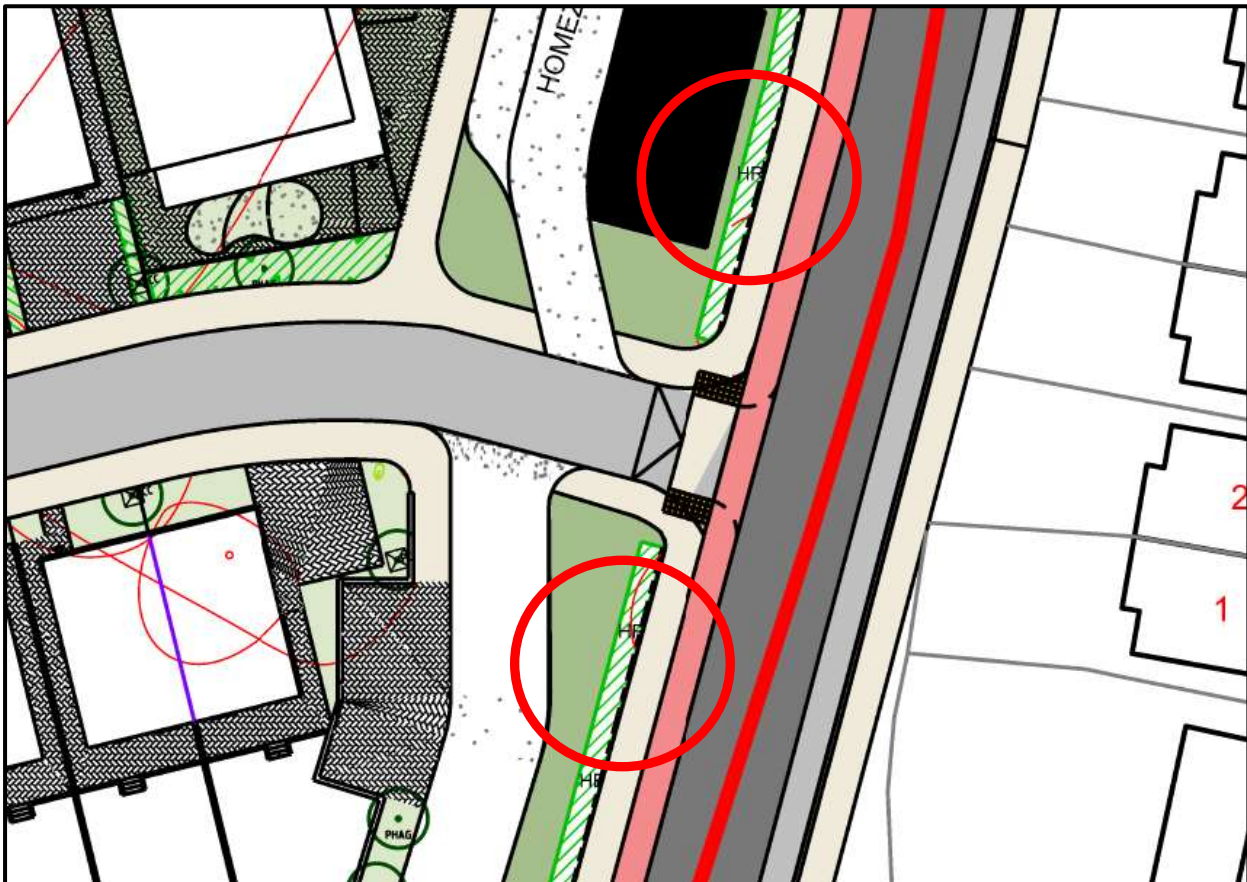
### Problem No.6: Landscape Details at Main Entrance and Internal Junctions

#### Location: Proposed Scheme

The audit team note that there is landscaping proposed either side of the main entrances and internal junctions which could restrict sightline visibility at junctions. Trees, high bushes, and shrubbery should be avoided in areas where visibility is to be maintained to ensure that drivers are clearly able to see approaching vehicles and pedestrians at junctions and designated pedestrian crossing locations. This could potentially lead to instances of vehicle-vehicle or pedestrian-vehicle collisions resulting in injury.

The design team should ensure that any proposed landscaping does not impact on visibility of the internal roads and junctions or forward visibility at the proposed pedestrian crossings.

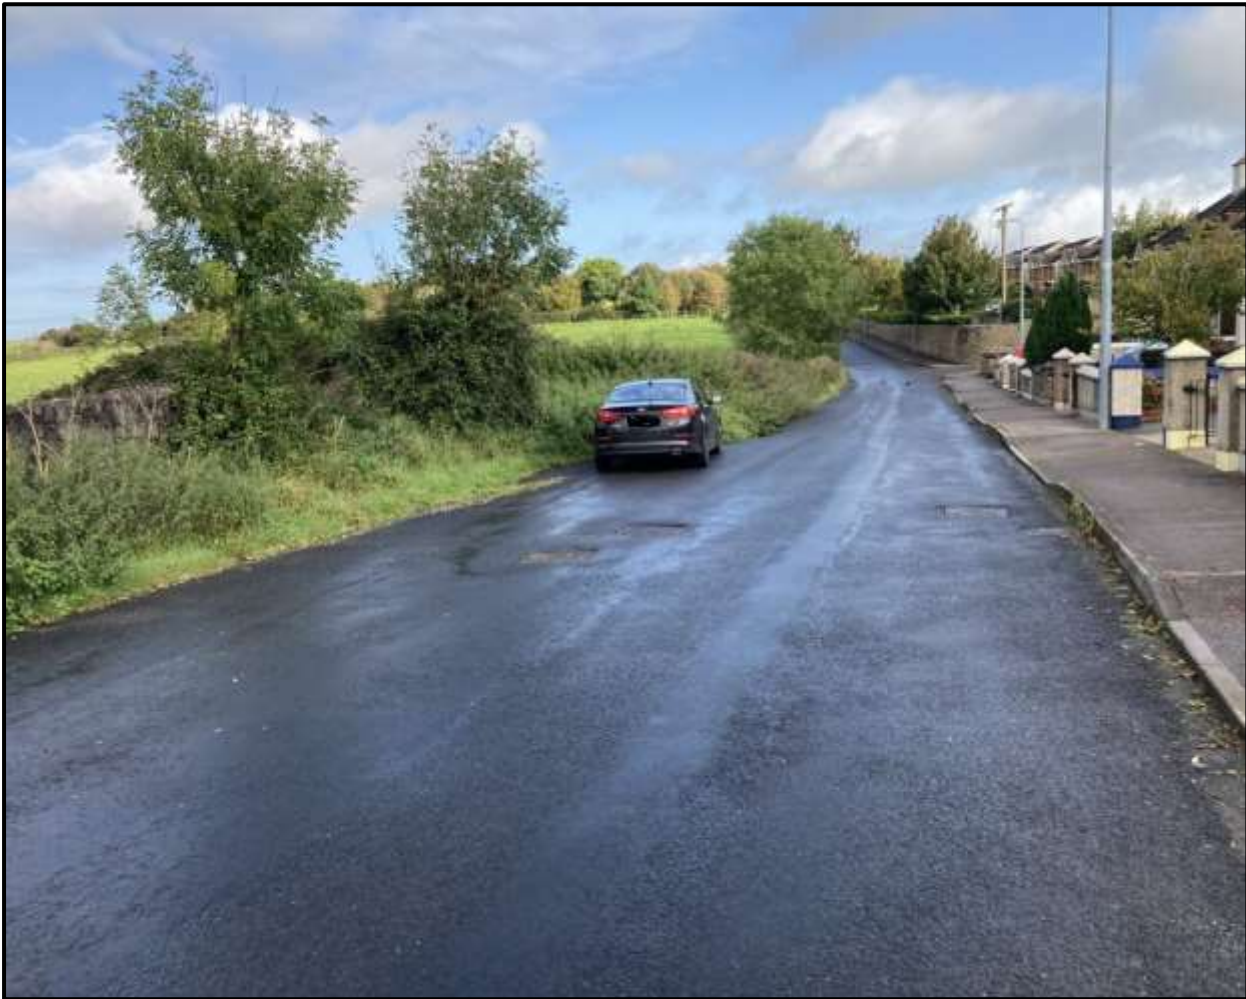
## **Problem No.7: Tie in with Caltragh Road Geometry**

### **Location: Site Access Points**

The audit team note that Caltragh Road currently does not have cycle lanes as detailed on the proposed plans and as such the audit team is unsure if the proposed development will tie into the existing arrangement on site or whether upgrades will be carried out to Caltragh Road in advance of opening the development up to traffic. The audit team would have concerns with the limited pedestrian connectivity should the proposed scheme tie into the existing arrangements on Caltragh Road.

The design team should ensure that the proposed development ties in with the proposed arrangements as detailed on the plans. If this is not possible the team should ensure that appropriate measures are provided to ensure appropriate pedestrian connectivity is provided to the existing arrangements on the opposite side of Caltragh Road.

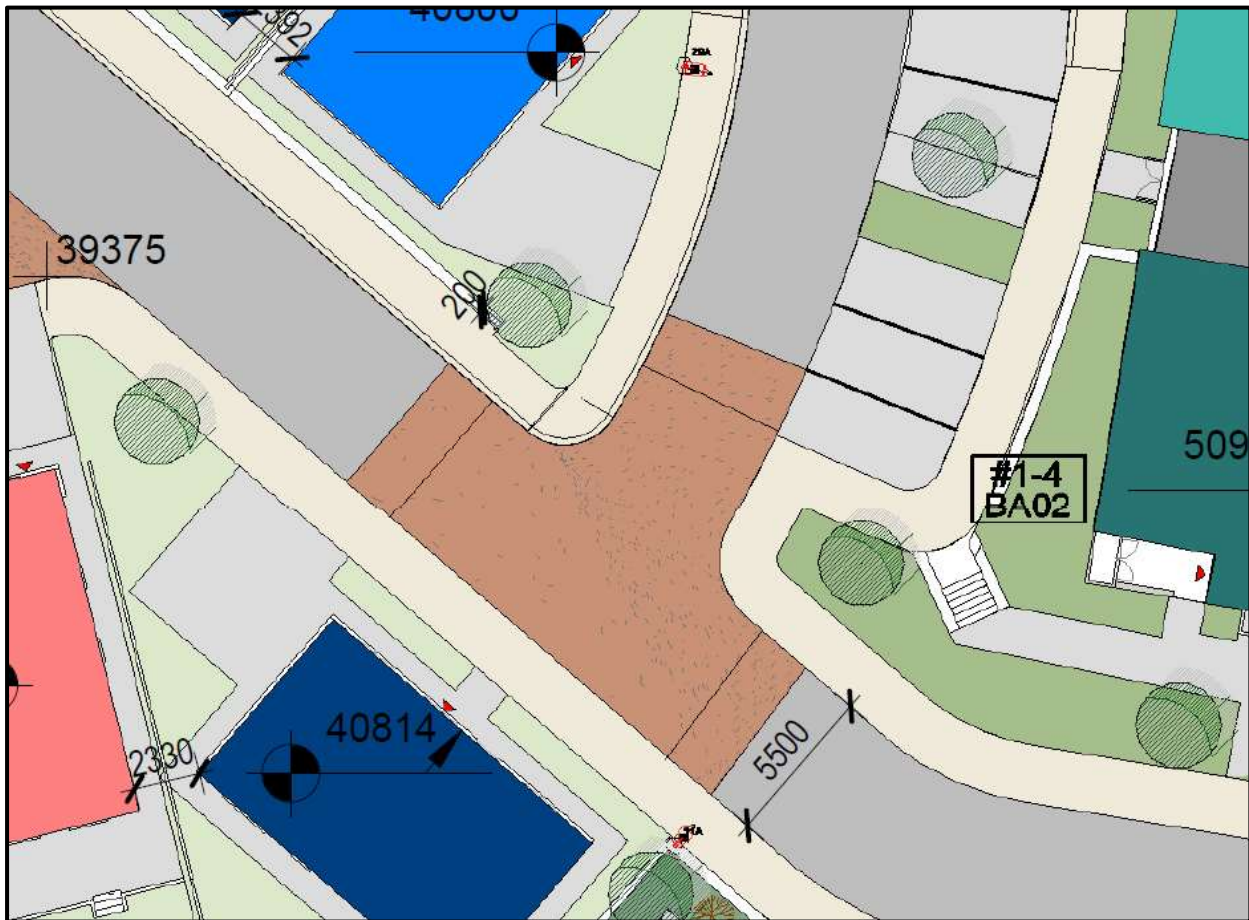
### Problem No.8: Raised Table Ramps Positioned Over Parking Spaces

**Location:** Throughout Development at Raise Table Locations

The audit team note that the ramps for the raised tables appear to straddle or cross over the entrances to parking bays throughout the scheme. This could result in potential trips and falls for users when walking to the rear of their vehicles. There is a particular risk at night when the ramps may be harder to notice.

The design team should ensure that the proposed ramps for the raised tables do not interact with the proposed parling bays throughout the scheme.
