# **Arboricultural Report**

Tree Survey,
Arboricultural Impact Assessment &
Arboricultural Method Statement

Newtownholms Road

230320-PD-11-A

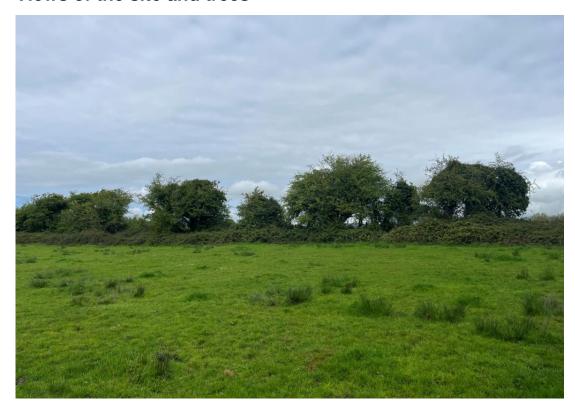
Photo 1: View of the northern boundary hawthorn hedgerow H252 & H253.

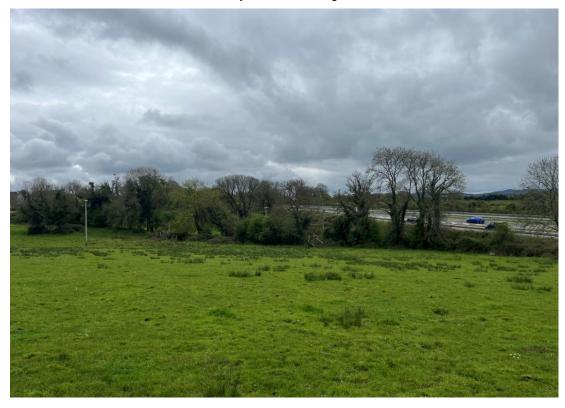
**Photo 2:** View of the mature hawthorn hedgerows (H258 & H260) and ash trees (T211 to T230) located within the southern section of the site which is at a much lower level than the northern boundary.

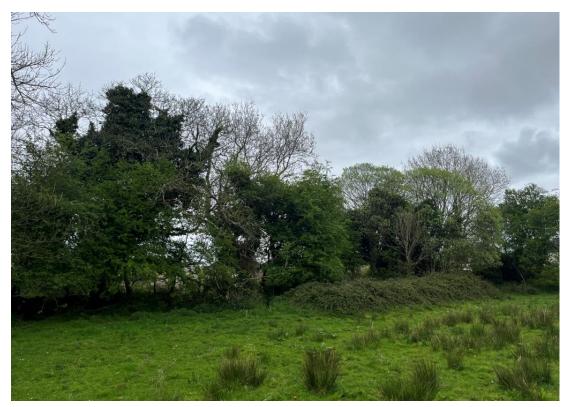
**Photo 3:** Second view showing the mature hawthorn hedgerow (H260) and ash trees (T211 to T219).

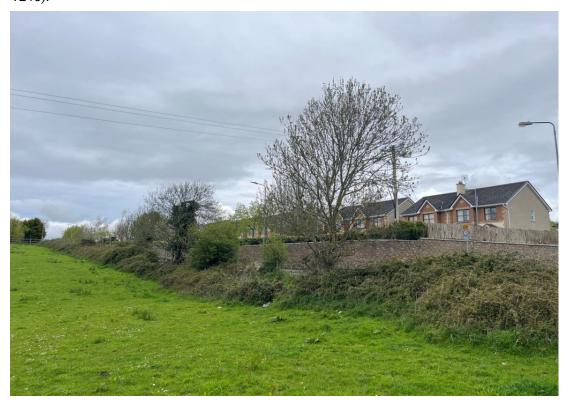
Photo 4: View of the eastern boundary ash trees (T261 to T265) and brambles (S267).

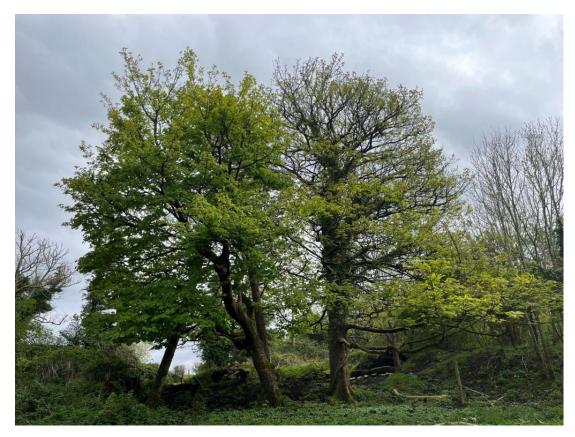
Photo 5: View of the mature sycamore trees T199 & T201.

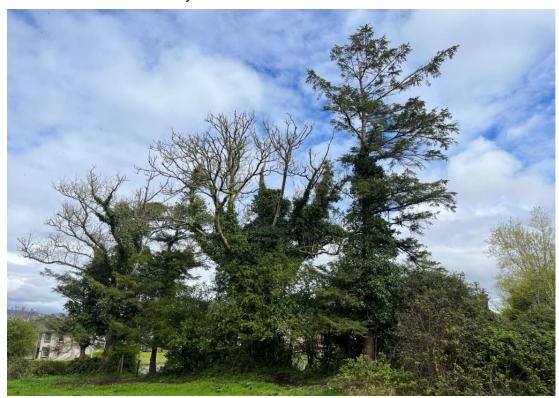
**Photo 6:** View of the poor quality ash T190 & T192 and the low quality spruce T189, T191 & T193.

Tree T190	1 Fraxinus excelsior (Ash)	13.0	110	1	7.5	6.5	6.0	7.5	5.0		Late Mature	Structural condition Poor. Physiological condition Poor. Dieback - Throughout crown. Decline - Evident / observed. Deadwood - Major. Decay / structural defect - Suspected.	28/04/2023	547.4	13.2	0-10	U
Tree T191	Picea sitchensis     (Sitka Spruce)	11.0	27	1	3.5	3.5	3.0	4.0	1.5		Early Mature	Structural condition Fair. Physiological condition Fair. Deadwood - Minor. Foreign object - Ingrown metal. Ivy or climbing plant. Root damage - Mammal. Raised surface roots.	28/04/2023	33.0	3.2	10-20	C2
Tree T192	1 Fraxinus excelsior (Ash)	13.5	80	1	7.0	7.5	5.0	7.0	6.0		Mature	Structural condition Poor. Physiological condition Poor. Access to inspect base - Restricted / obscured. Die-back - Throughout crown. Decline - Evident / observed. Deadwood - Major. Decay / structural defect - Suspected. Ivy or climbing plant.	28/04/2023	289.5	9.6	0-10	U
