**CALTRAGH LRD  
NEWTOWNHOLMES ROAD,  
CALTRAGH AND CORNAGEEHA  
CO. SLIGO**

**SCREENING FOR APPROPRIATE ASSESSMENT**

**APRIL 2024**

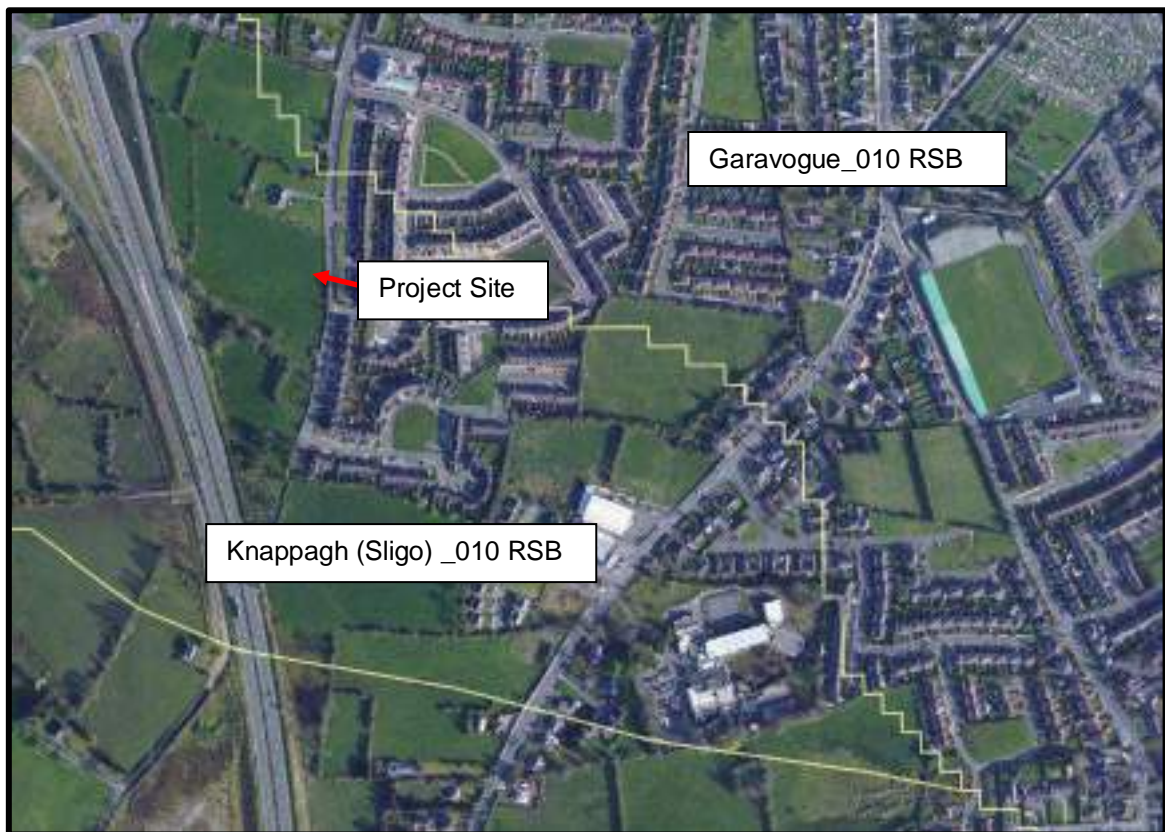
**Figure 3.1:** WFD River Sub Basin (RSB) and orthographic view of surrounding landscape

The Project is wholly located within the Knappagh (Sligo)\_010 WFD River Sub Basin (RSB) covering an area of approximately 18km<sup>2</sup> (Figure 3.1). The RSB had 'Moderate' ecological status for the 2016-2021 period remains unchanged from the 2013-2018 period. The 2010-2015, 2010-2012 and the 2007-2009 periods are unassigned.

As noted earlier in Section 3.2, the Proposed Housing Development is within the WFD River Sub Basin Knappagh (Sligo)\_010. Currently, there are no significant nitrogen or phosphorus pressures from the Project on this River Sub Basin.

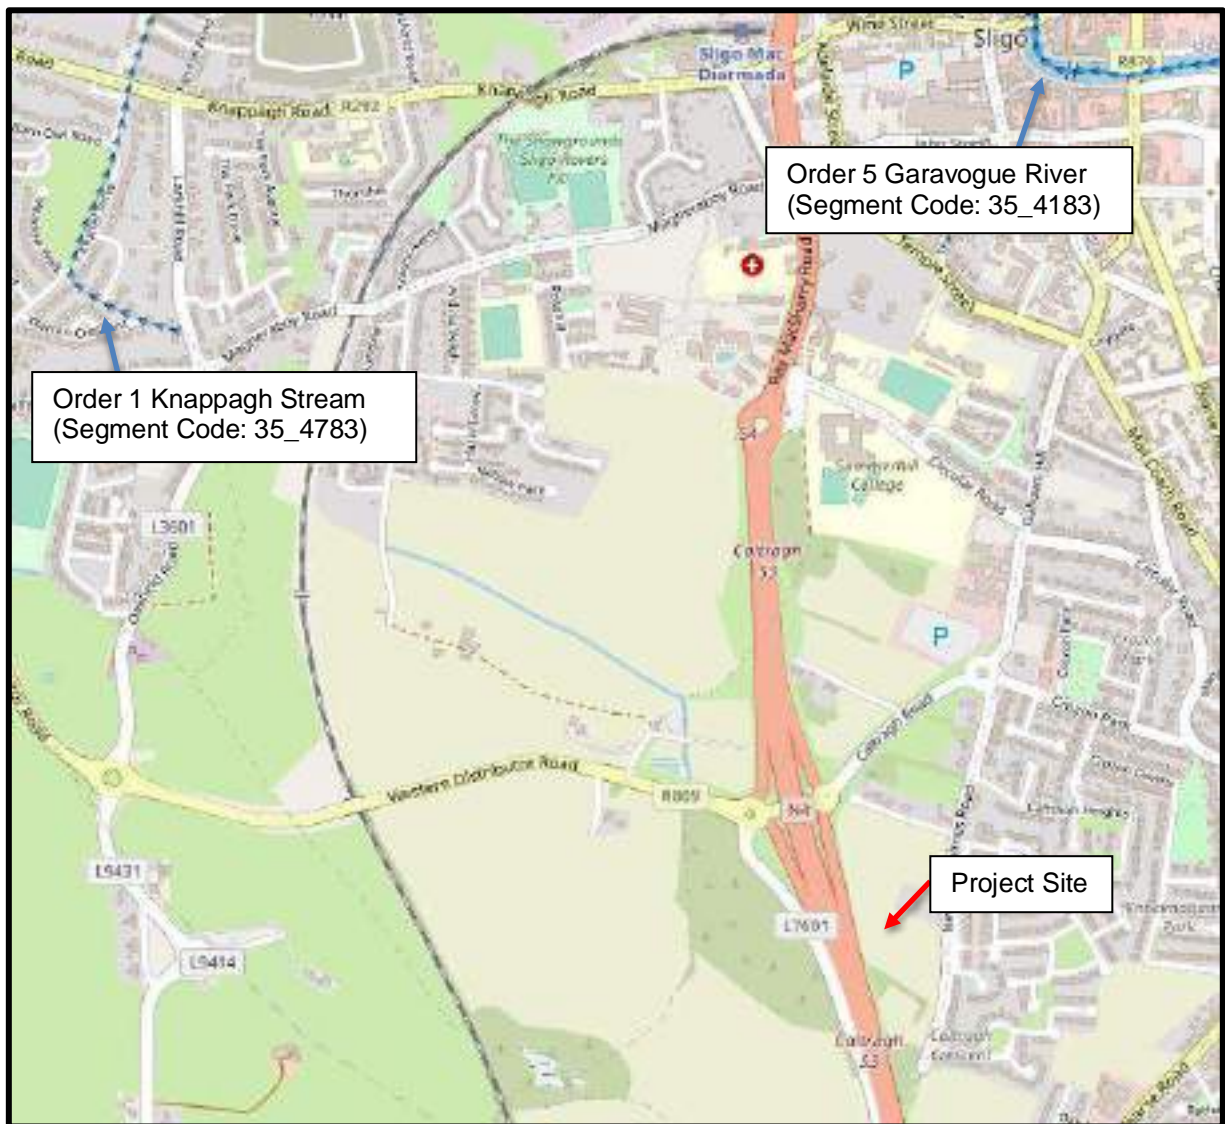
**Figure 3.2:** Watercourses and waterbodies in the vicinity of the Project

The order 5 Garavogue River (Segment Code: 35\_4183) lies approximately 1.5km north of the Project (Figure 3.2). The Garavogue River flows in a north westerly direction for approximately 2.1km and discharges into Cummeen Strand and subsequently the Atlantic Ocean.

The order 1 Knappagh (35) stream (Segment Code: 35\_4783) lies approximately 1.6km northwest of the Project (Figure 3.2). The Knappagh stream flows in a northwesterly direction for approximately 2km and discharges into the Cummeen Strand which is part of the Cummeen Strand/Drumcliff Bay (Sligo Bay) SAC and Cummeen Strand SPA. It subsequently flows into Drumcliff Bay and the Atlantic Ocean. There are no other water features proximate to the Project.

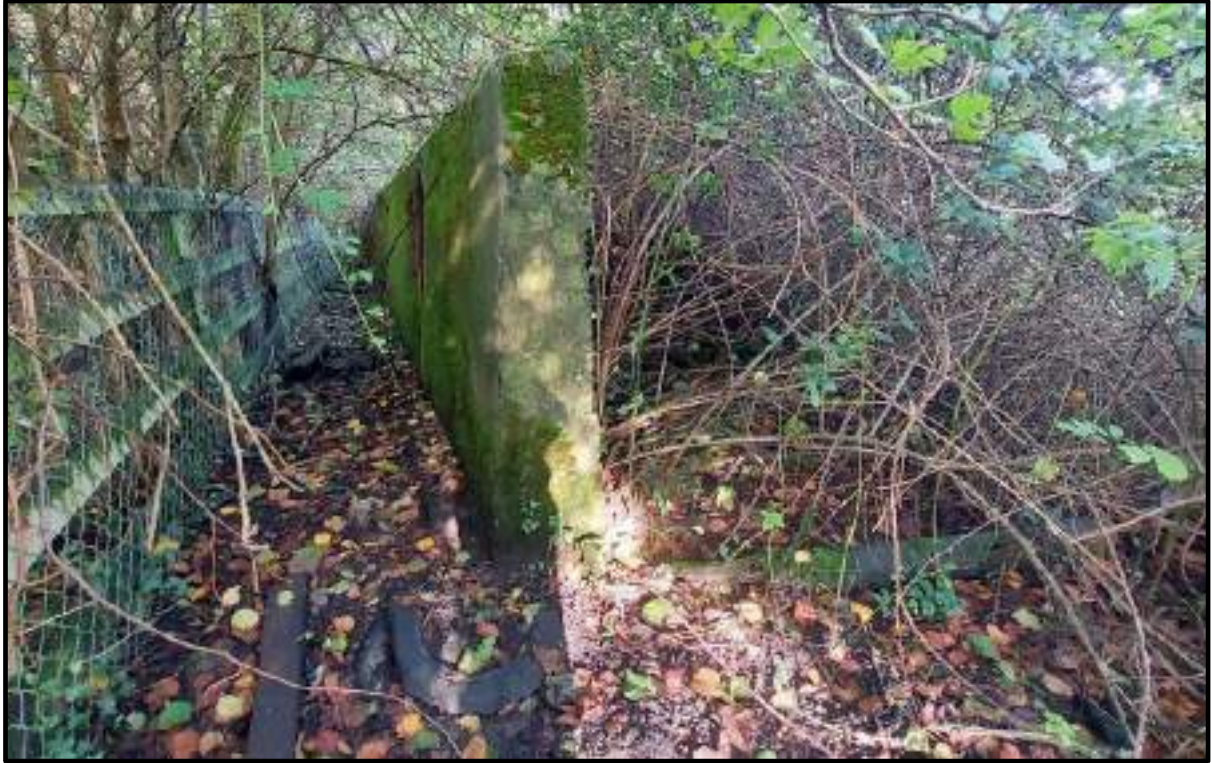
**Plate 3.1** Artificial substrate at the south end of the site.

This broad category incorporates all the areas of the Project that are covered with artificial surfaces. Such surfaces are limited onsite and restricted to the field boundaries and include a cement plastered wall approx. 1.5m tall x 0.3m wide that is located under the cover of overhead vegetation from trees rooted in the neighbouring field and provides dense bramble support on its northside. Mosses have

successfully gained a foothold in this shaded environment, but no herbaceous vegetation, with the exception of a very limited amount of *Hedera hibernica* (ivy). A second wall (stone and plaster wall, capped with cement) exists for a brief section of the eastern site boundary. Similarly, no vegetation has gained a foothold on this artificial substrate. There are several variations of fencing (post and wire most common) around and within the site, which sometimes support bramble (*Rubus fruticosus* agg.).

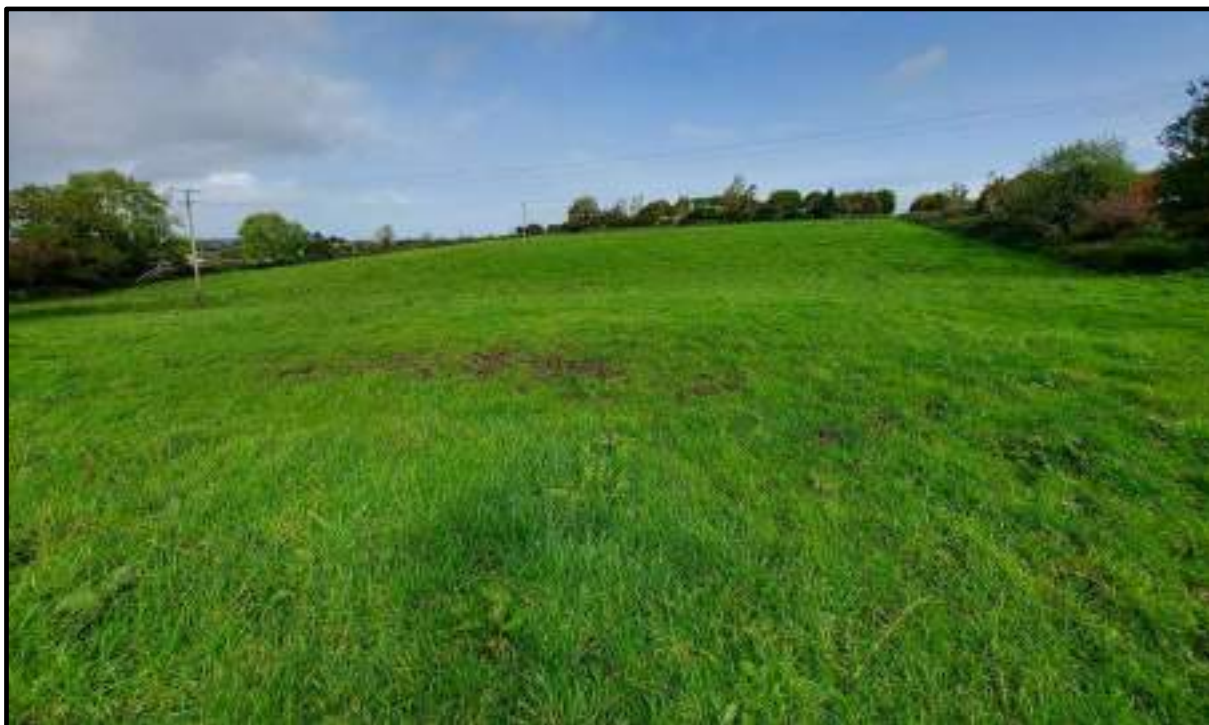
**Plate 3.2 Improved agricultural grassland is the primary habitat onsite**

This is the predominant habitat onsite and represents most of the fields/land on a moderately sloping terrain. On occasion, the land retains water and where poorly drained, the habitat transitions to wet grassland habitat. The grassland has been grazed (and possibly used for silage making), keeping the sward height relatively low and the land heavily poached over much of the site.

This habitat can be classified as highly modified agricultural grassland that has been reseeded and/or regularly fertilised. Overall species richness is poor with the grass species heavily dominated by *Lolium perenne* (rye-grass). *Holcus lanatus* (Yorkshire fog), *Poa* spp. (meadow grass), *Cynosurus cristatus* (Crested dog's tail ) are present but do not dominate the composition. *Agrostis stolonifera* (creeping bent) was also noted closer to the field margins, intertwining with bramble. *Trifolium repens* (white clover) is abundant throughout this habitat and also heavily represented in the wet grassland (GS4) habitat also. Agricultural herbs include *Ranunculus repens* (creeping buttercup), *R. acris* (meadow buttercup), *Plantago lanceolata* (narrow-leaved plantain), *Rumex obtusifolius* (broad-leaved dock), *R. crispus* (curled dock), *Cirsium arvense* (creeping thistle), *Cirsium dissectum* (meadow thistle), *Cirsium vulgare* (spear thistle), *Rumex acetosa* (common sorrel), *Potentilla anserina* (silverweed) and *Taraxacum* spp. (Dandelion). Ungrazed stands of *Jacobaea vulgaris* (ragwort) are common throughout the fields.

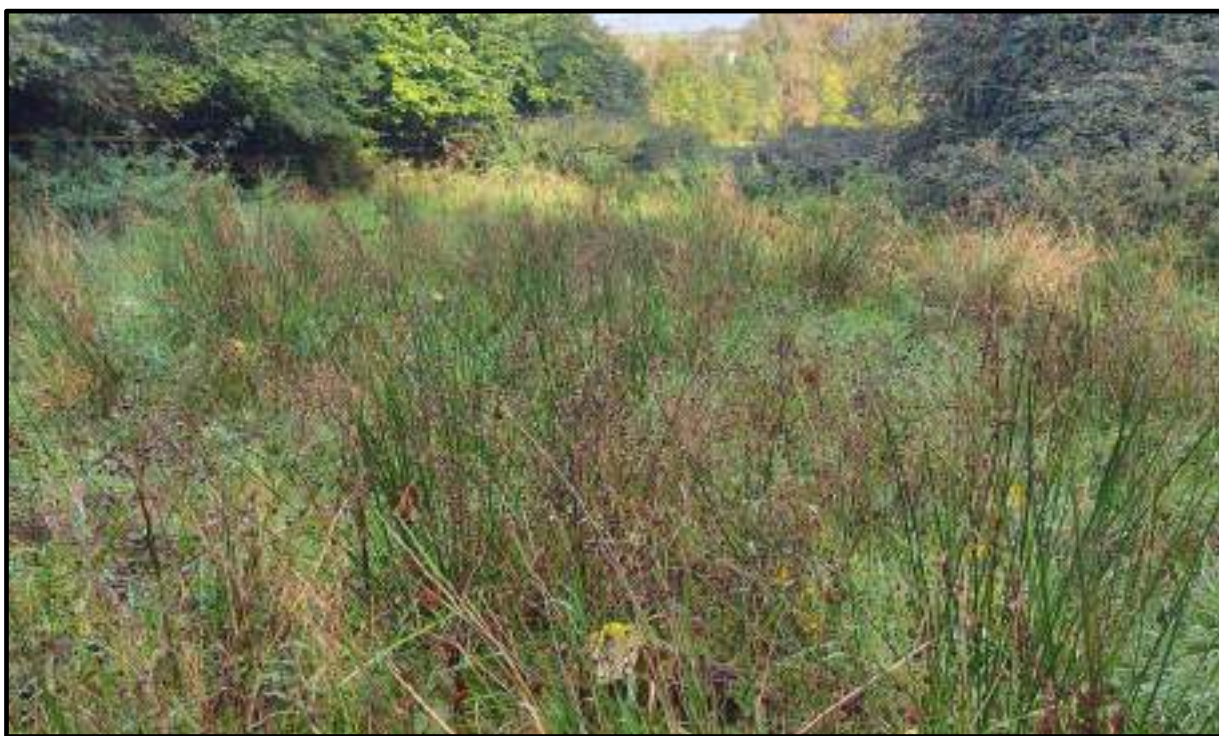
**Plate 3.3** Wet grassland habitat (GS\$) in the southwest corner of the site.

As noted above, there are areas of wet grassland where the land is poorly drained and heavily poached. Alongside the species composition noted above for habitat GA1, rushes (*Juncus effusus*) are a

conspicuous component of this habitat type. *Cirsium palustre* (marsh thistle) and *Irish pseudacorus* (yellow iris) are also present on occasion.

The floral composition however shows signs that this habitat has been modified in the past, as diversity is relatively poor and reflects poorly drained soils. Underlying the upright vegetation are abundant mosses. Tussocks of soft rush (*Juncus effusus*) and hard rush (*Juncus inflexus*) are both common, in addition to grasses such as cock's foot (*Dactylus glomerata*), Yorkshire-fog (*Holcus lanatus*) and creeping bent (*Agrostis stolonifera*). Marsh thistle (*Cirsium palustre*), meadow thistle (*Cirsium dissectum*) and spear thistle (*Cirsium vulgare*) are present. Both meadow buttercup (*Ranunculus acris*) and creeping buttercup (*R. repens*) are well represented, mixed with clovers (*Trifolium* spp.), dandelion (*Taraxacum* sp.), narrow-leaved plantain (*Plantago lanceolata*), broad-leaved plantain (*Plantago major*) and daisy (*Bellis perennis*) amongst others. Broad-leaved dock (*Rumex obtusifolius*) and bush vetch (*Vicia sepium*) are also present onsite. Towards the south end of this habitat, there is an area where young willow saplings have gained a foothold and are between 1.25 – 1.5m (approximately) tall. Also, bramble (*Rubus fruticosus* agg.) is creating a dense strip area along the riparian zone merging with this wet grassland habitat. Cleavers (*Galium aparine*) are utilising the bramble as a foothold to gain height and spread. Great willowherb (*Epilobium hirsutum*) and Angelika (*Angelica archangelica*) are also located at the south end of the field where conditions are wetter.

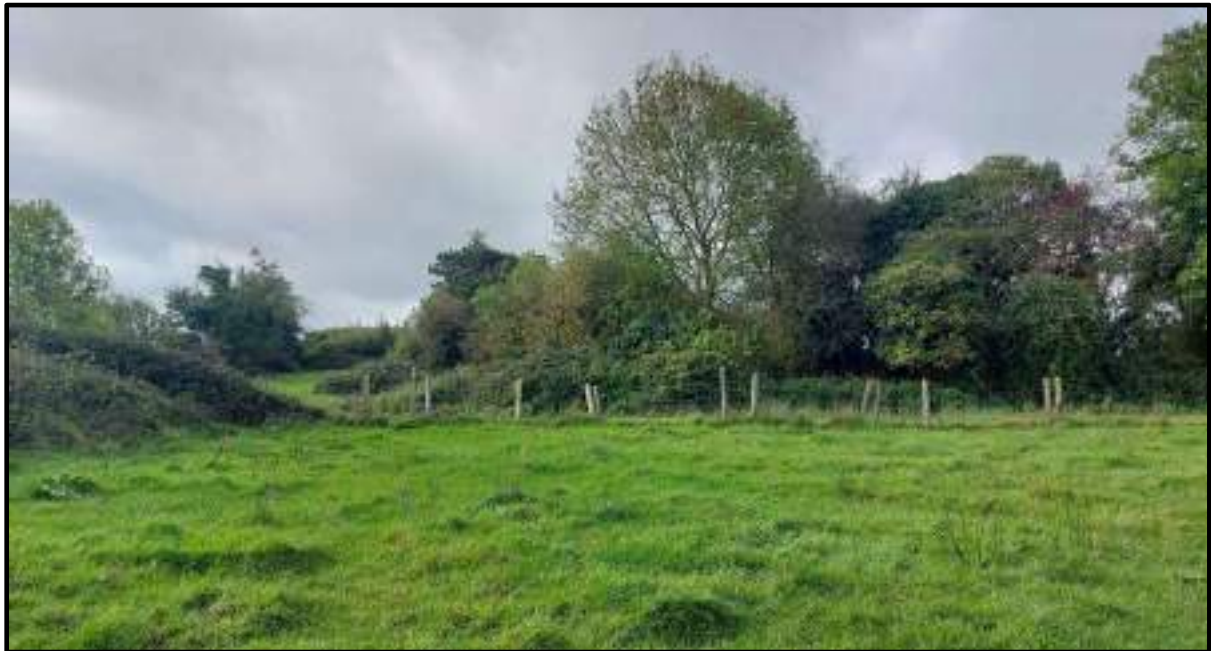
**Plate 3.4** Treeline / hedgerow / scrub habitats onsite.

There are seven hedgerows onsite of different age groups and structure; they predominantly support native species, including *Fraxinus excelsior* (ash), *Crataegus monogyna* (hawthorn), *Salix fragilis* (crack willow), *Salix caprea* (goat willow), *Sambucus nigra* (elder), *Prunus spinosa* (Blackthorn), *Alnus glutinosa* (alder) and *Betula pendula* (silver birch). Other species include *Sorbus torminalis* (wild service /chequers tree) and *Acer pseudoplatanus* (sycamore). Many of the hedgerows are heavily encroached by *Rubus fruticosus* agg (bramble), so much so, in fact, that there are hedgerows (<2m tall) that are >90% comprised of bramble alone.

Scrub areas are generally dominated by bramble, nettles (*Urtica dioica*) and willowherb (*Epilobium* spp.) with a mix of different tree species as noted above. These areas extend some 6 x15m, 20 x 4m with smaller areas also present.

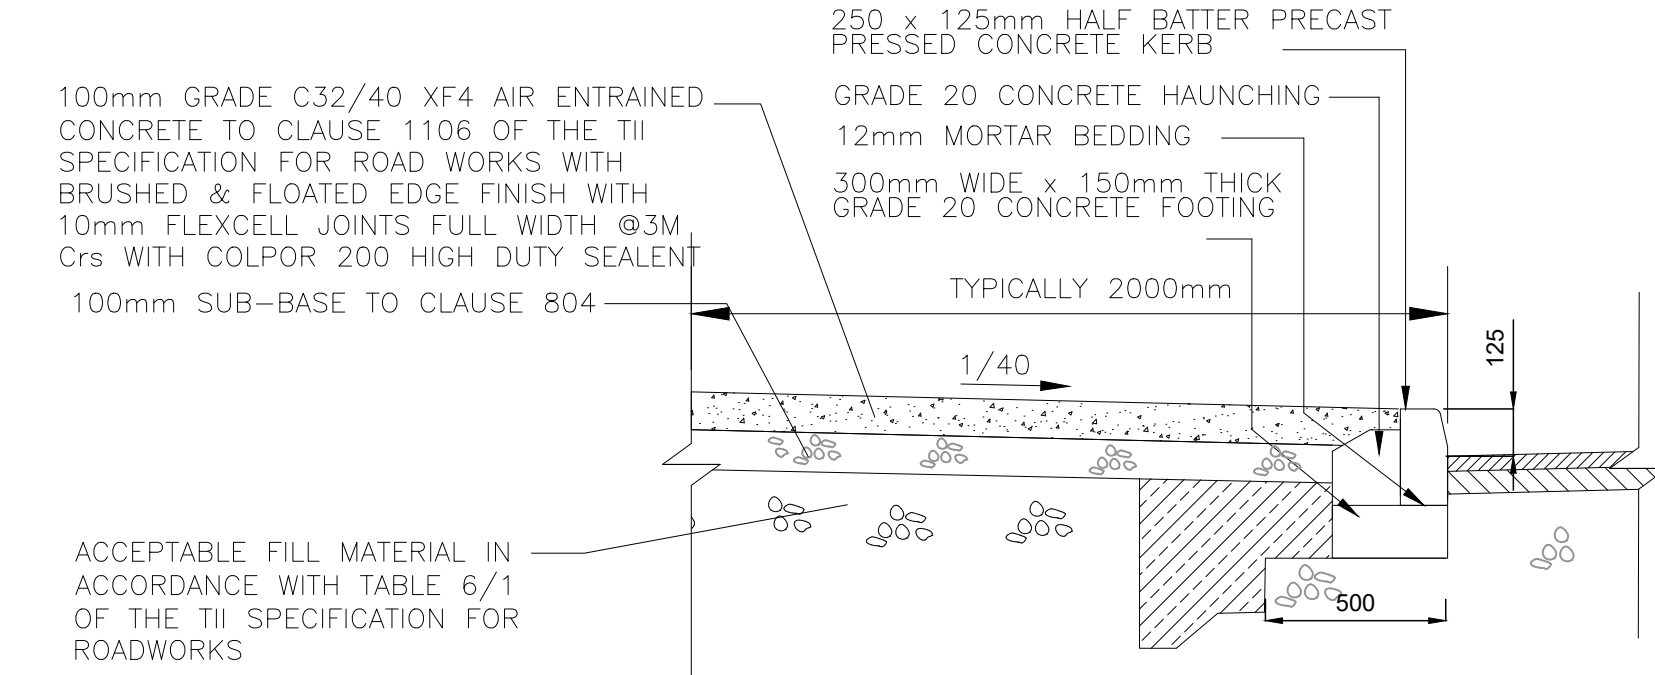
TYPICAL CONCRETE FOOTPATH CROSS SECTION  
SCALE: 1:20

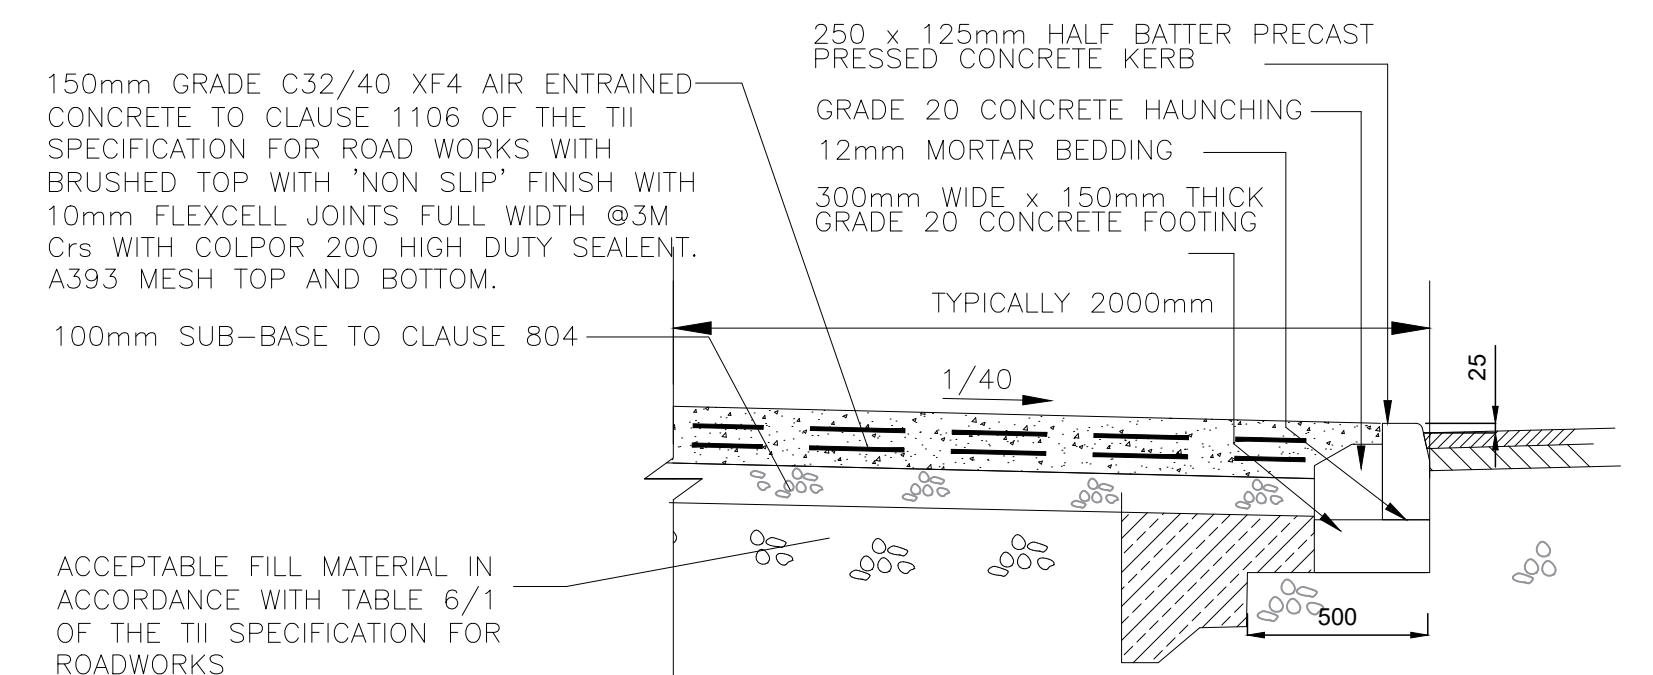
TYPICAL CONCRETE FOOTPATH CROSS SECTION  
AT DRIVEWAY ENTRANCES  
SCALE: 1:20

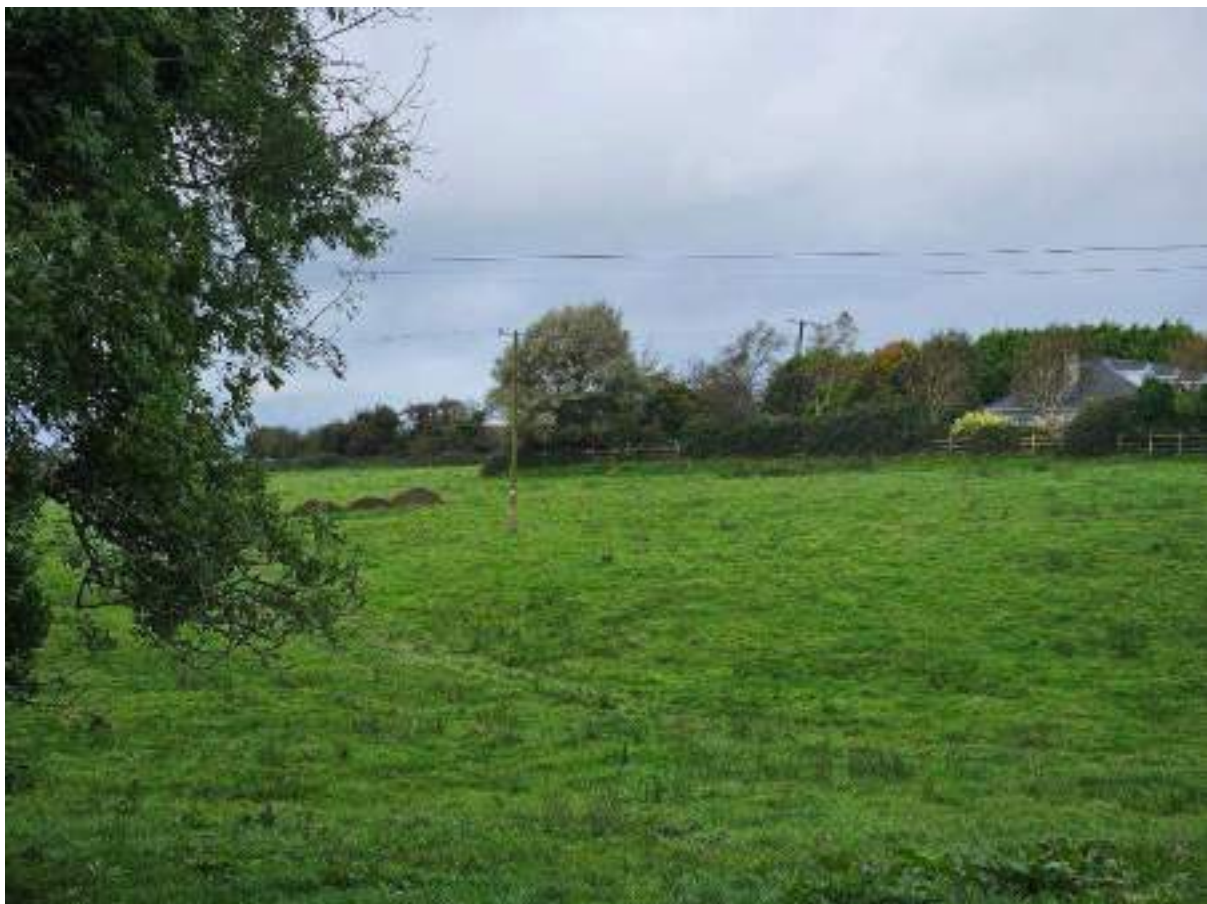
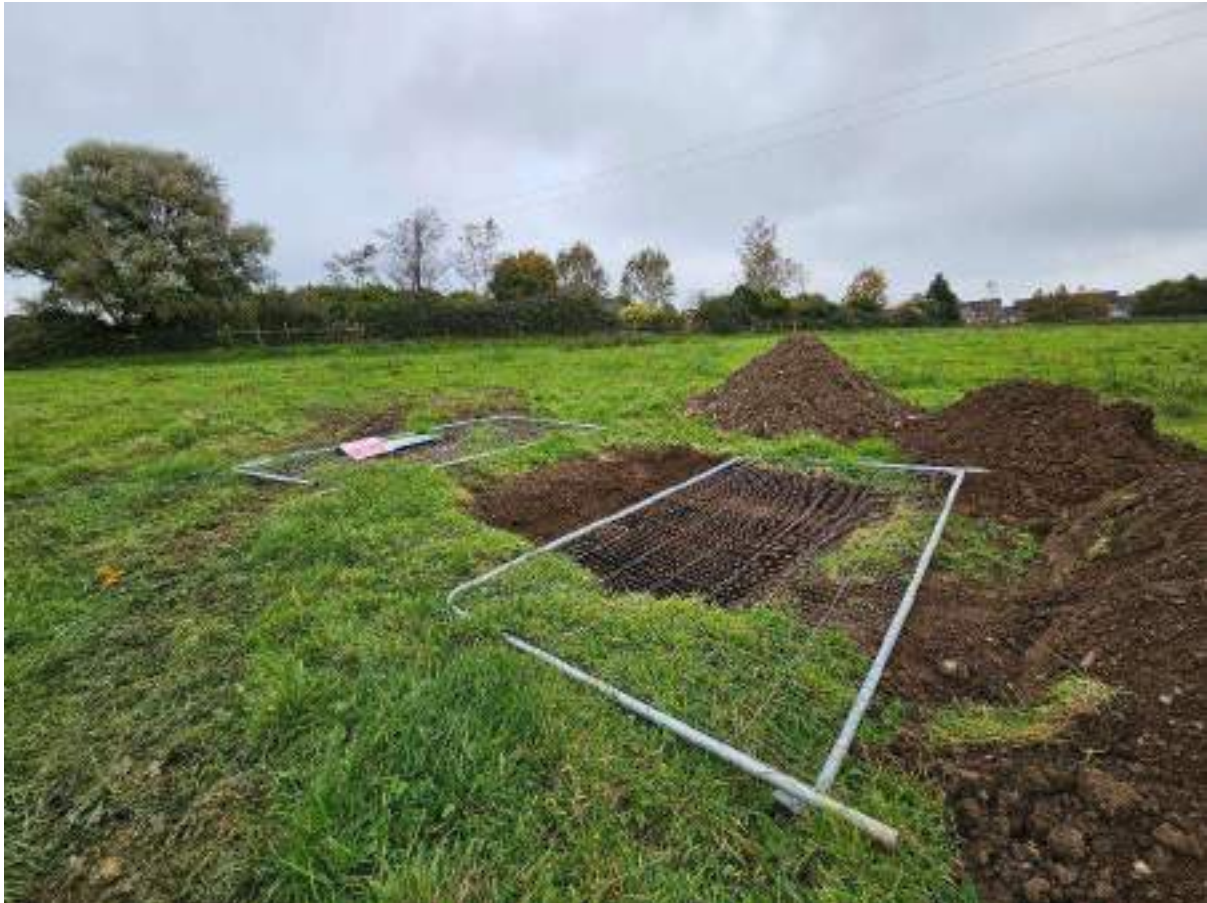
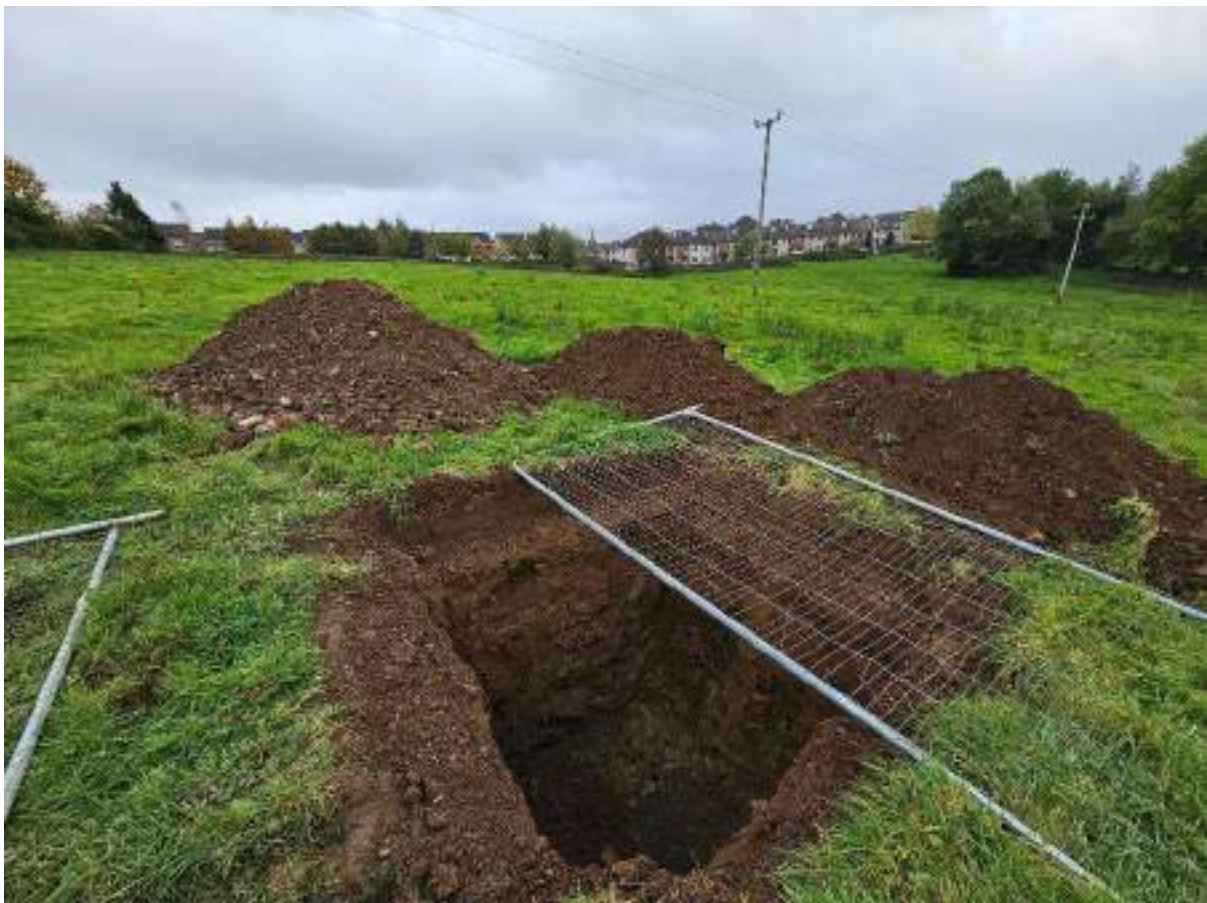
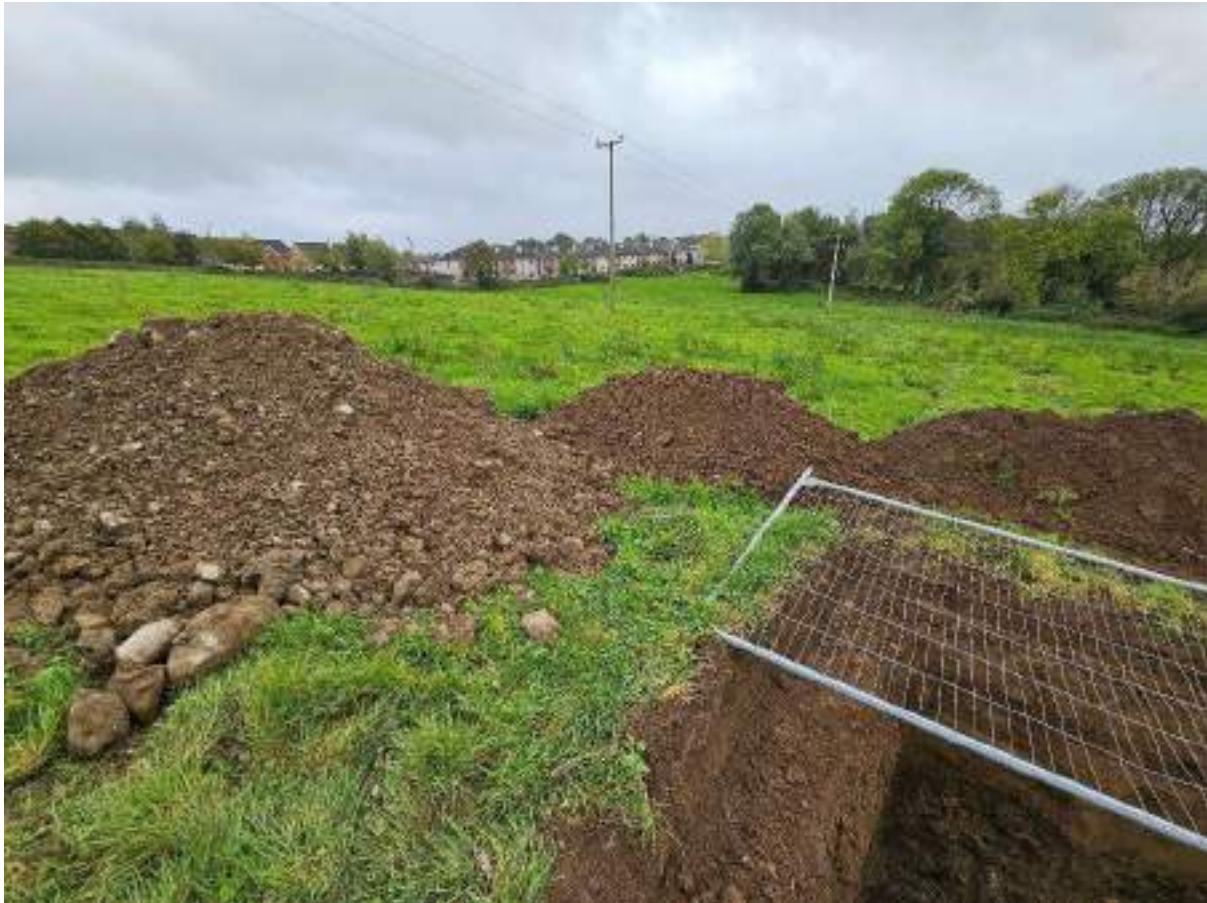
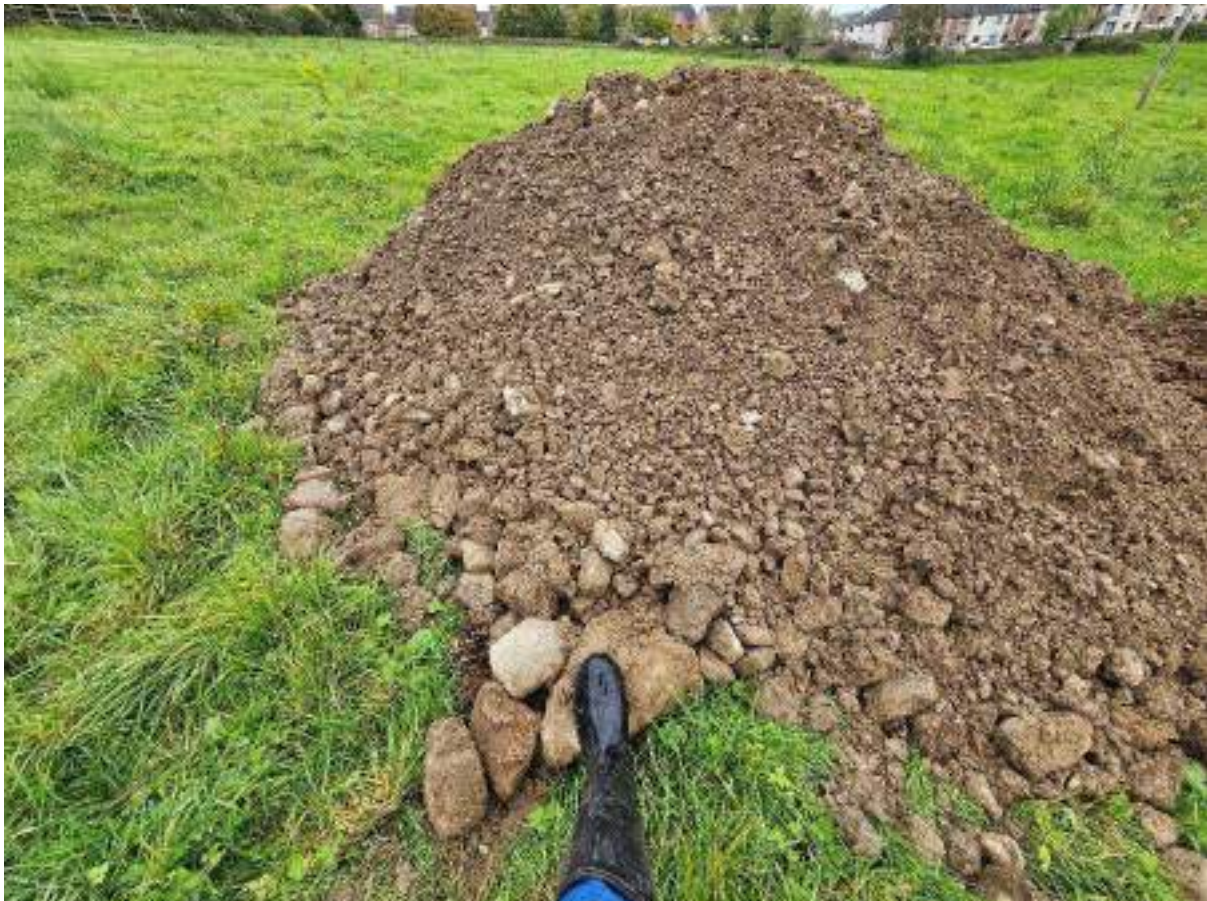
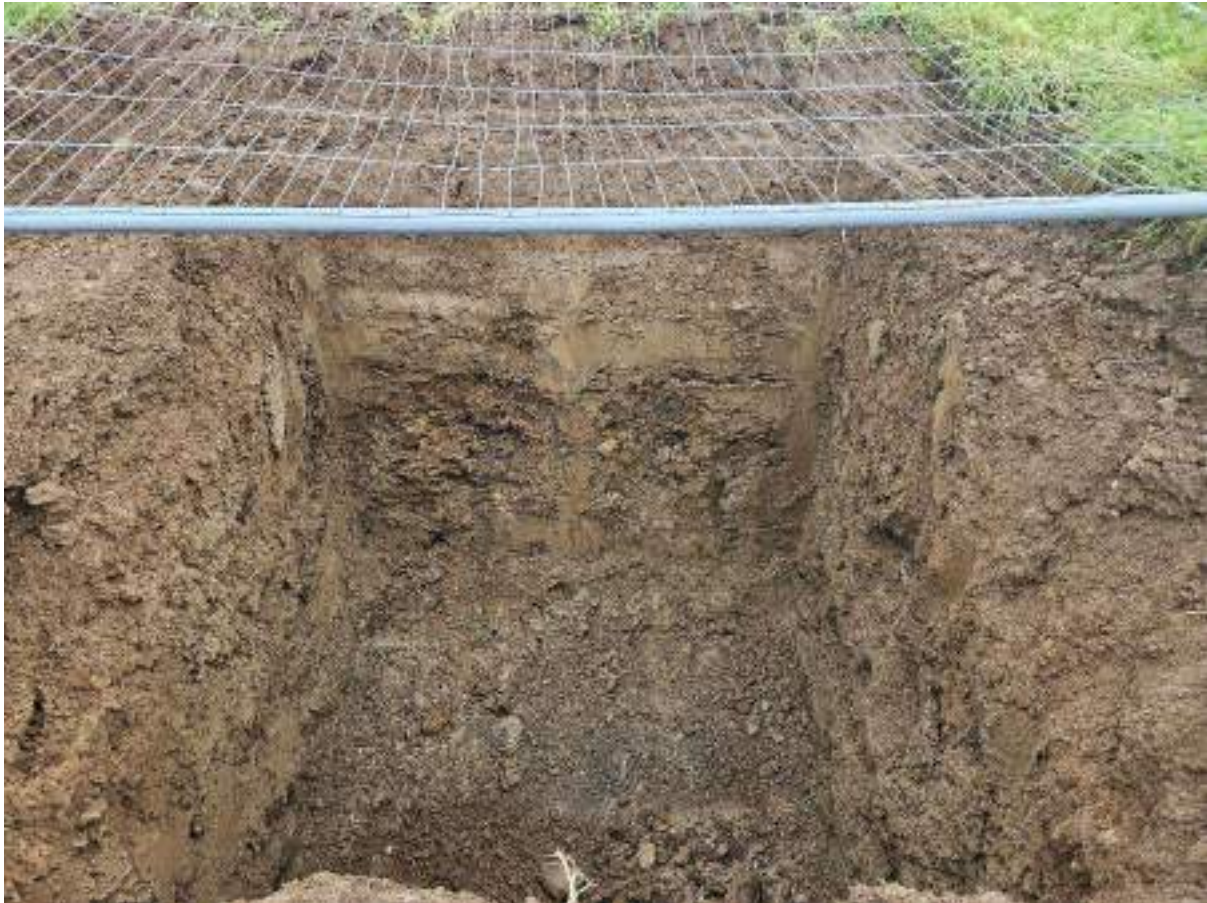
### **3. SITE PHOTOGRAPHS – TRIAL PIT 1**

The trial pits were inspected on the afternoon of Thursday 05/10/2023. No groundwater was present in either of the trial pits. The exposed soil comprised approximately 300mm of topsoil on sandy gravelly clay. As the depth increased cobbles were observed with increasing frequency.

Two trial pits were excavated in accordance with the attached sketch on the morning of Wednesday 04/10/2023. The trial pit depth of 2m was selected to match the formation level of the deepest excavations to be dug on site. No groundwater ingress was observed.

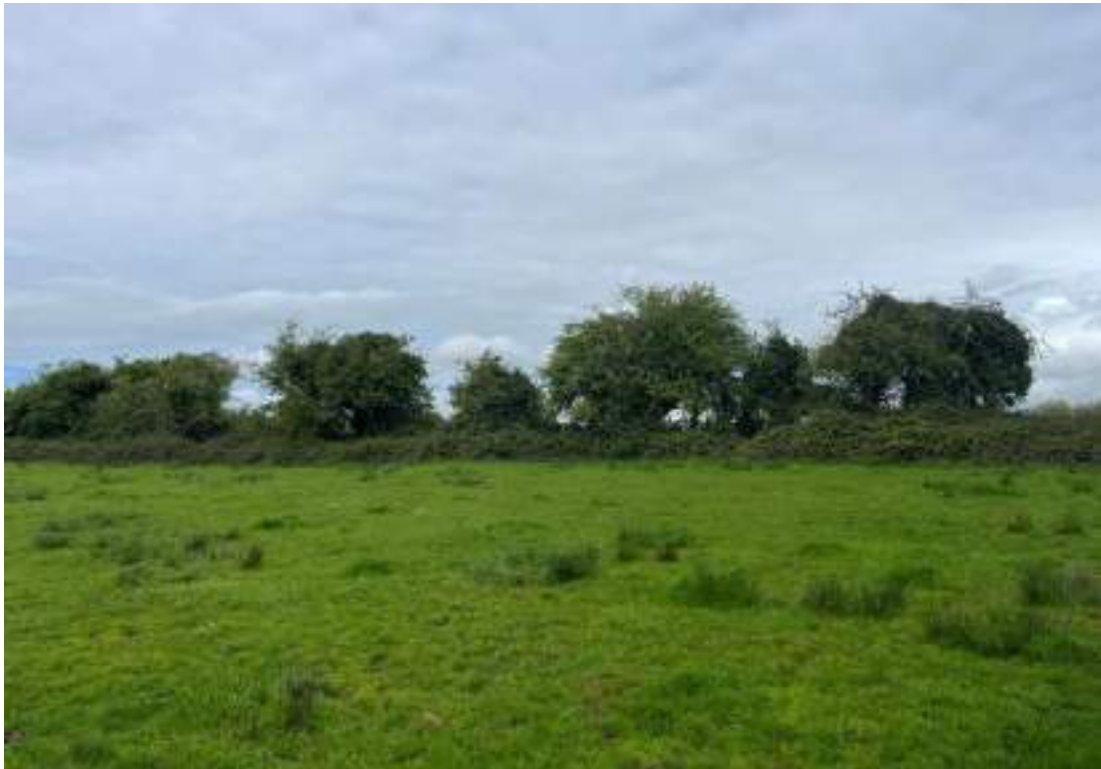
**Photo 1:** View of the northern boundary hawthorn hedgerow H252 & H253.

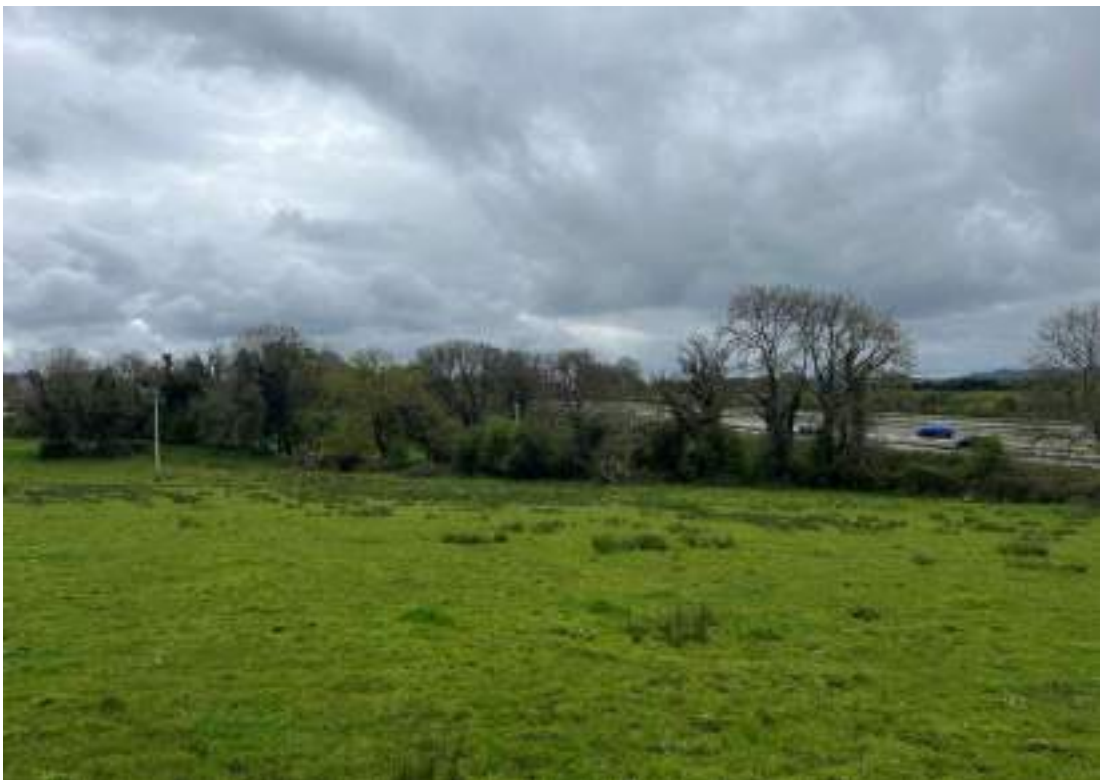
**Photo 2:** View of the mature hawthorn hedgerows (H258 & H260) and ash trees (T211 to T230) located within the southern section of the site which is at a much lower level than the northern boundary.

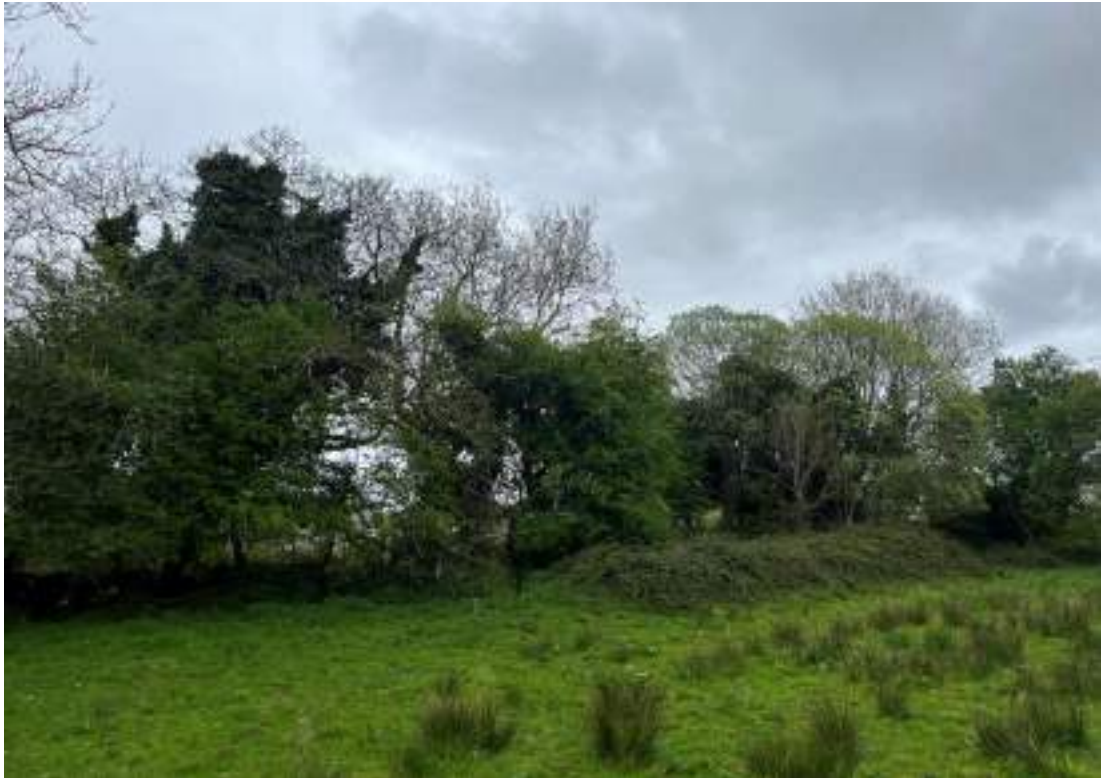
**Photo 3:** Second view showing the mature hawthorn hedgerow (H260) and ash trees (T211 to T219).

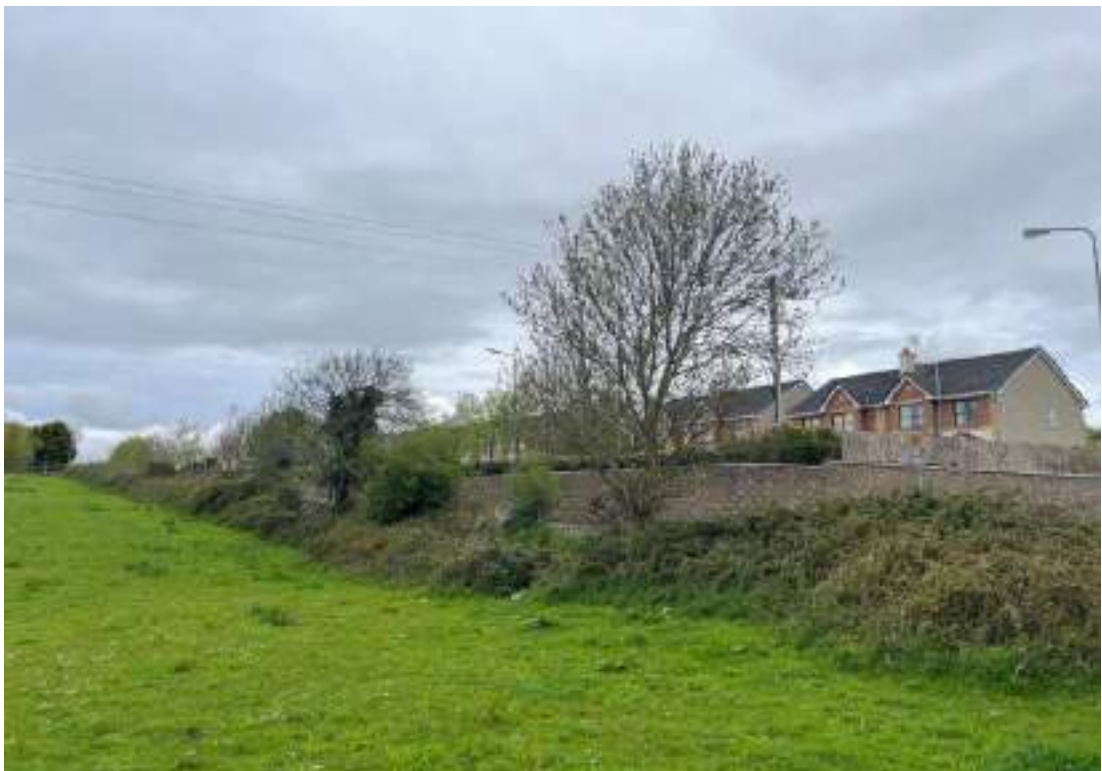
**Photo 4:** View of the eastern boundary ash trees (T261 to T265) and brambles (S267).

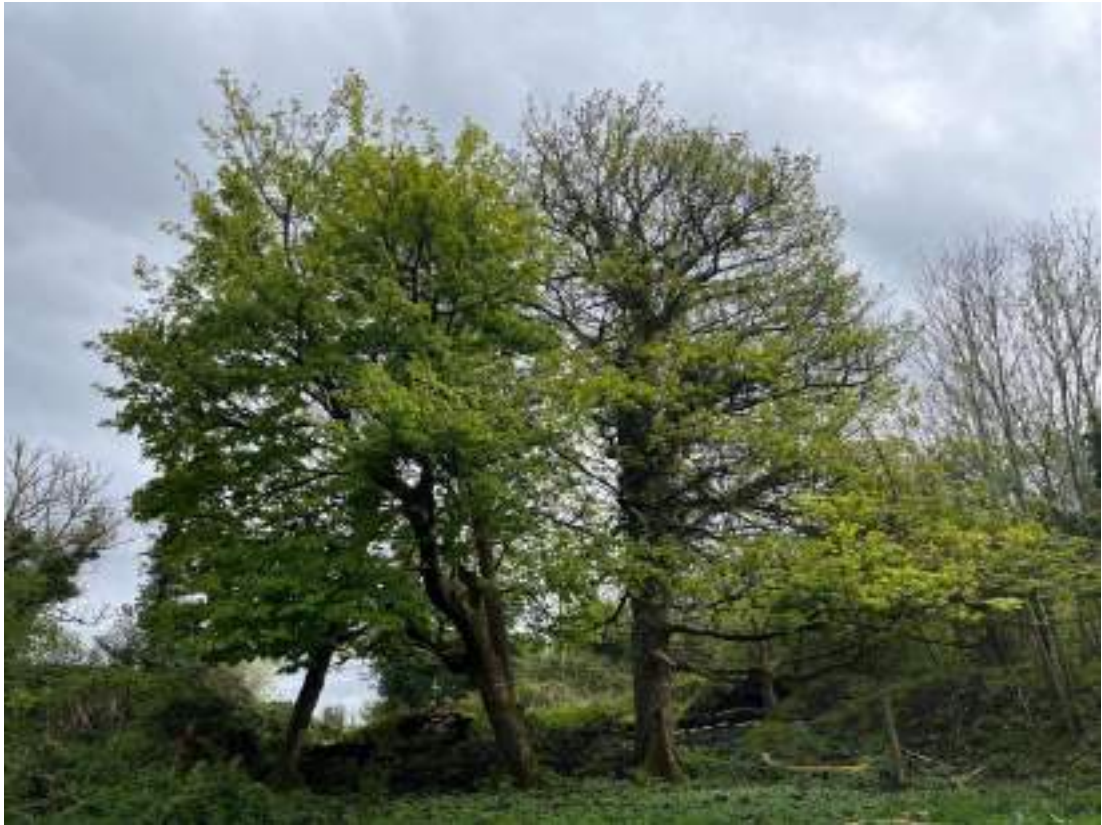
**Photo 5:** View of the mature sycamore trees T199 & T201.

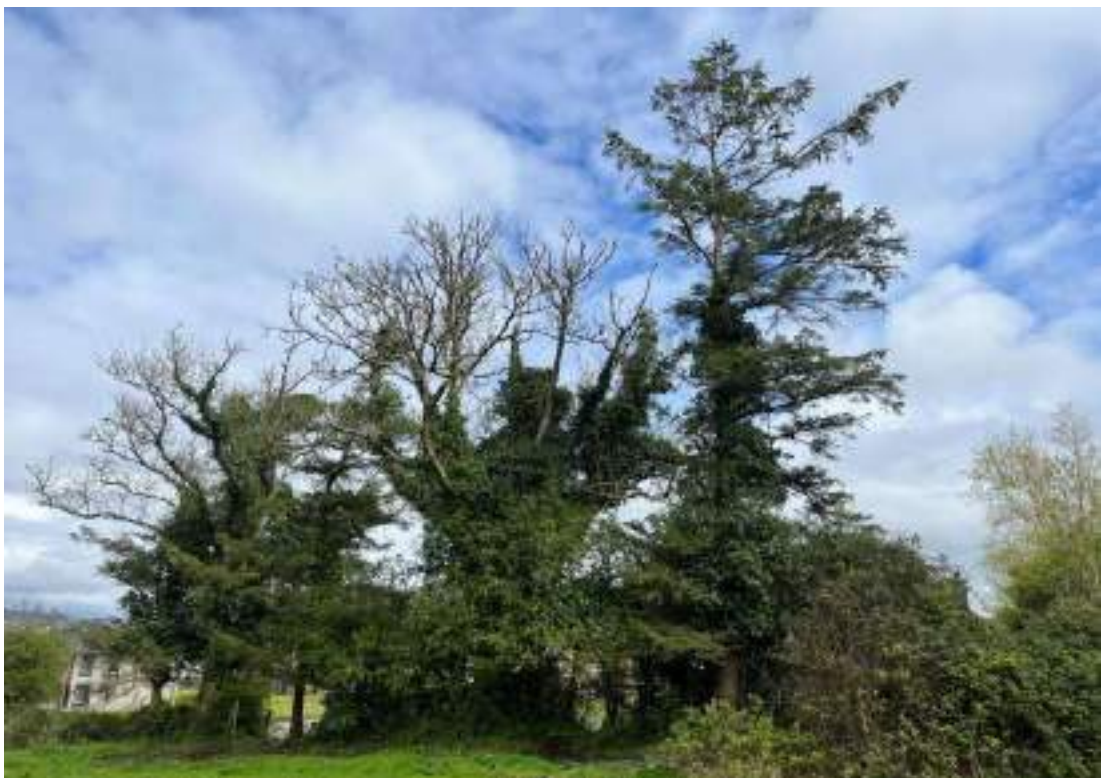
**Photo 6:** View of the poor quality ash T190 & T192 and the low quality spruce T189, T191 & T193.

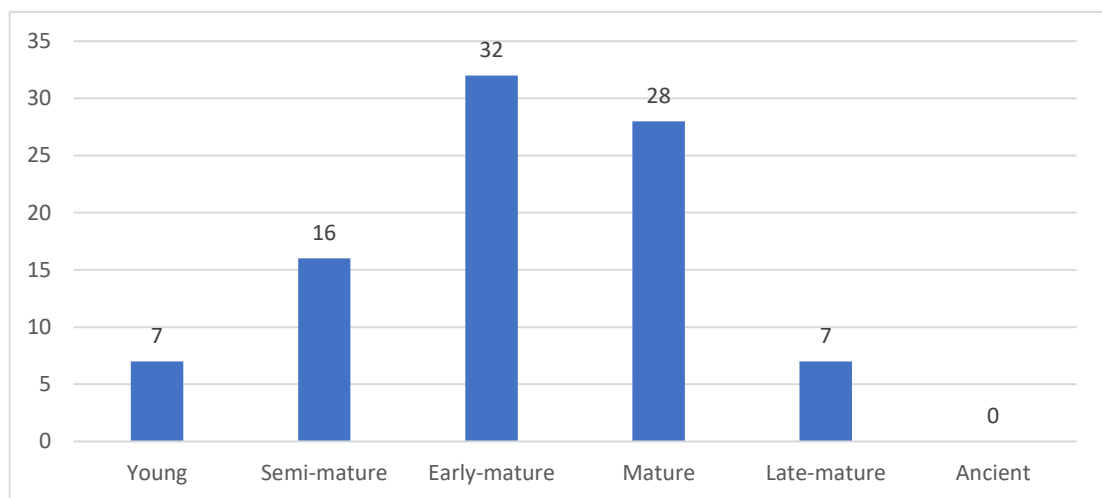
**Figure 1:** Life stage analysis of the 90 survey entries recorded.
