**CALTRAGH LRD  
NEWTOWNHOLMES ROAD,  
CALTRAGH AND CORNAGEEHA  
CO. SLIGO**

**SCREENING FOR APPROPRIATE ASSESSMENT**

**APRIL 2024**

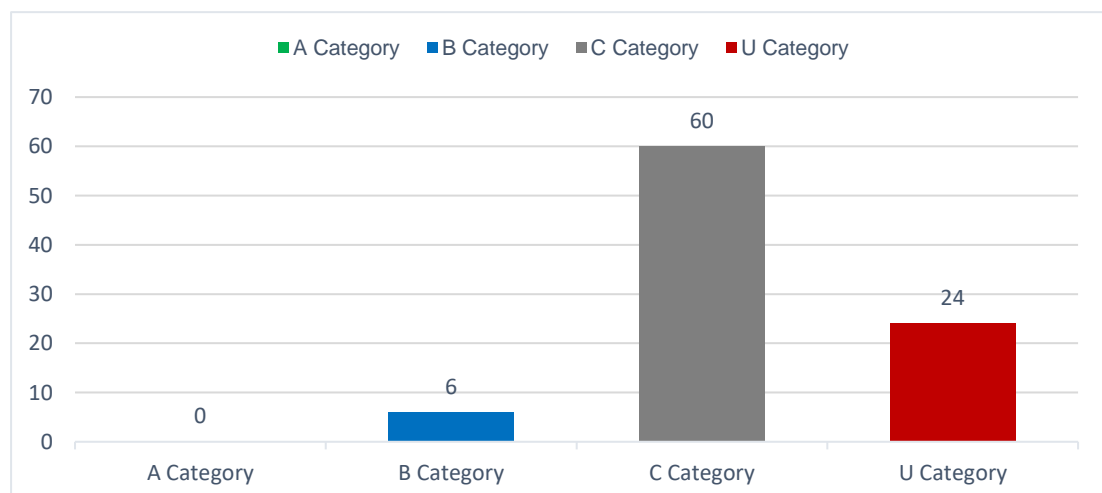
**Figure 2:** Breakdown of BS5837:2012 categories of the 90 survey entries recorded.

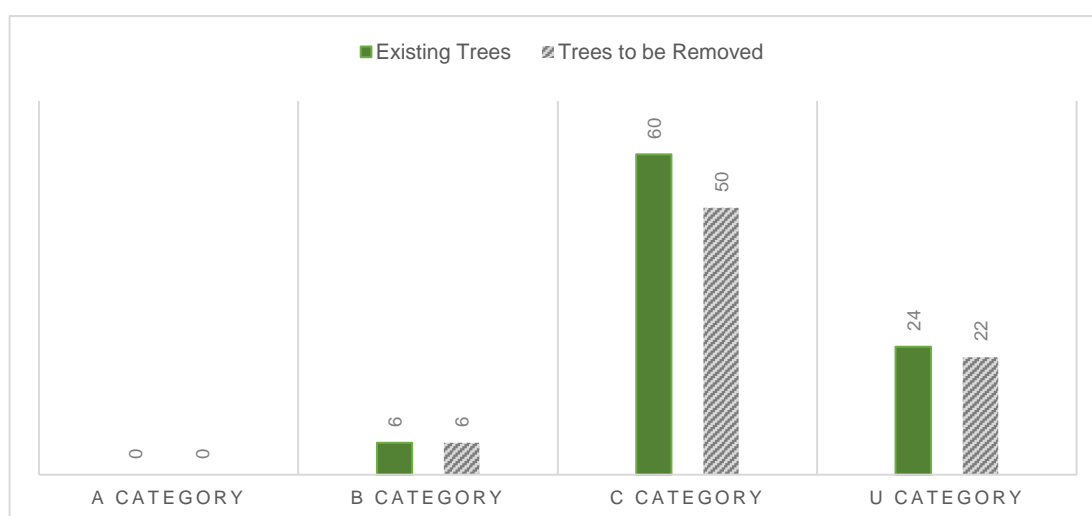
**Figure 3:** Breakdown of the proposed tree removals required to facilitate the development.

- 6.1 **Loss of trees** – The majority of trees and hedgerows located on the site are required to be removed to facilitate the proposed development. This includes 63 trees, one group of trees, seven hedgerows and seven groups of brambles.
- 6.2 Of the proposed removals, five trees and one hedgerow are of moderate quality and value (B Category), 36 trees, one tree group, six hedgerows and seven groups of brambles are of low quality and value (C Category) and 22 trees are of poor quality (U Category).
- 6.3 Details of the proposed tree removals are specified within the Tree Work Schedule at Appendix A and their location within the site is highlighted in the Tree Works Plan at Appendix B. A breakdown of tree removals according to their BS5837:2012 category is outlined in Figure 3.

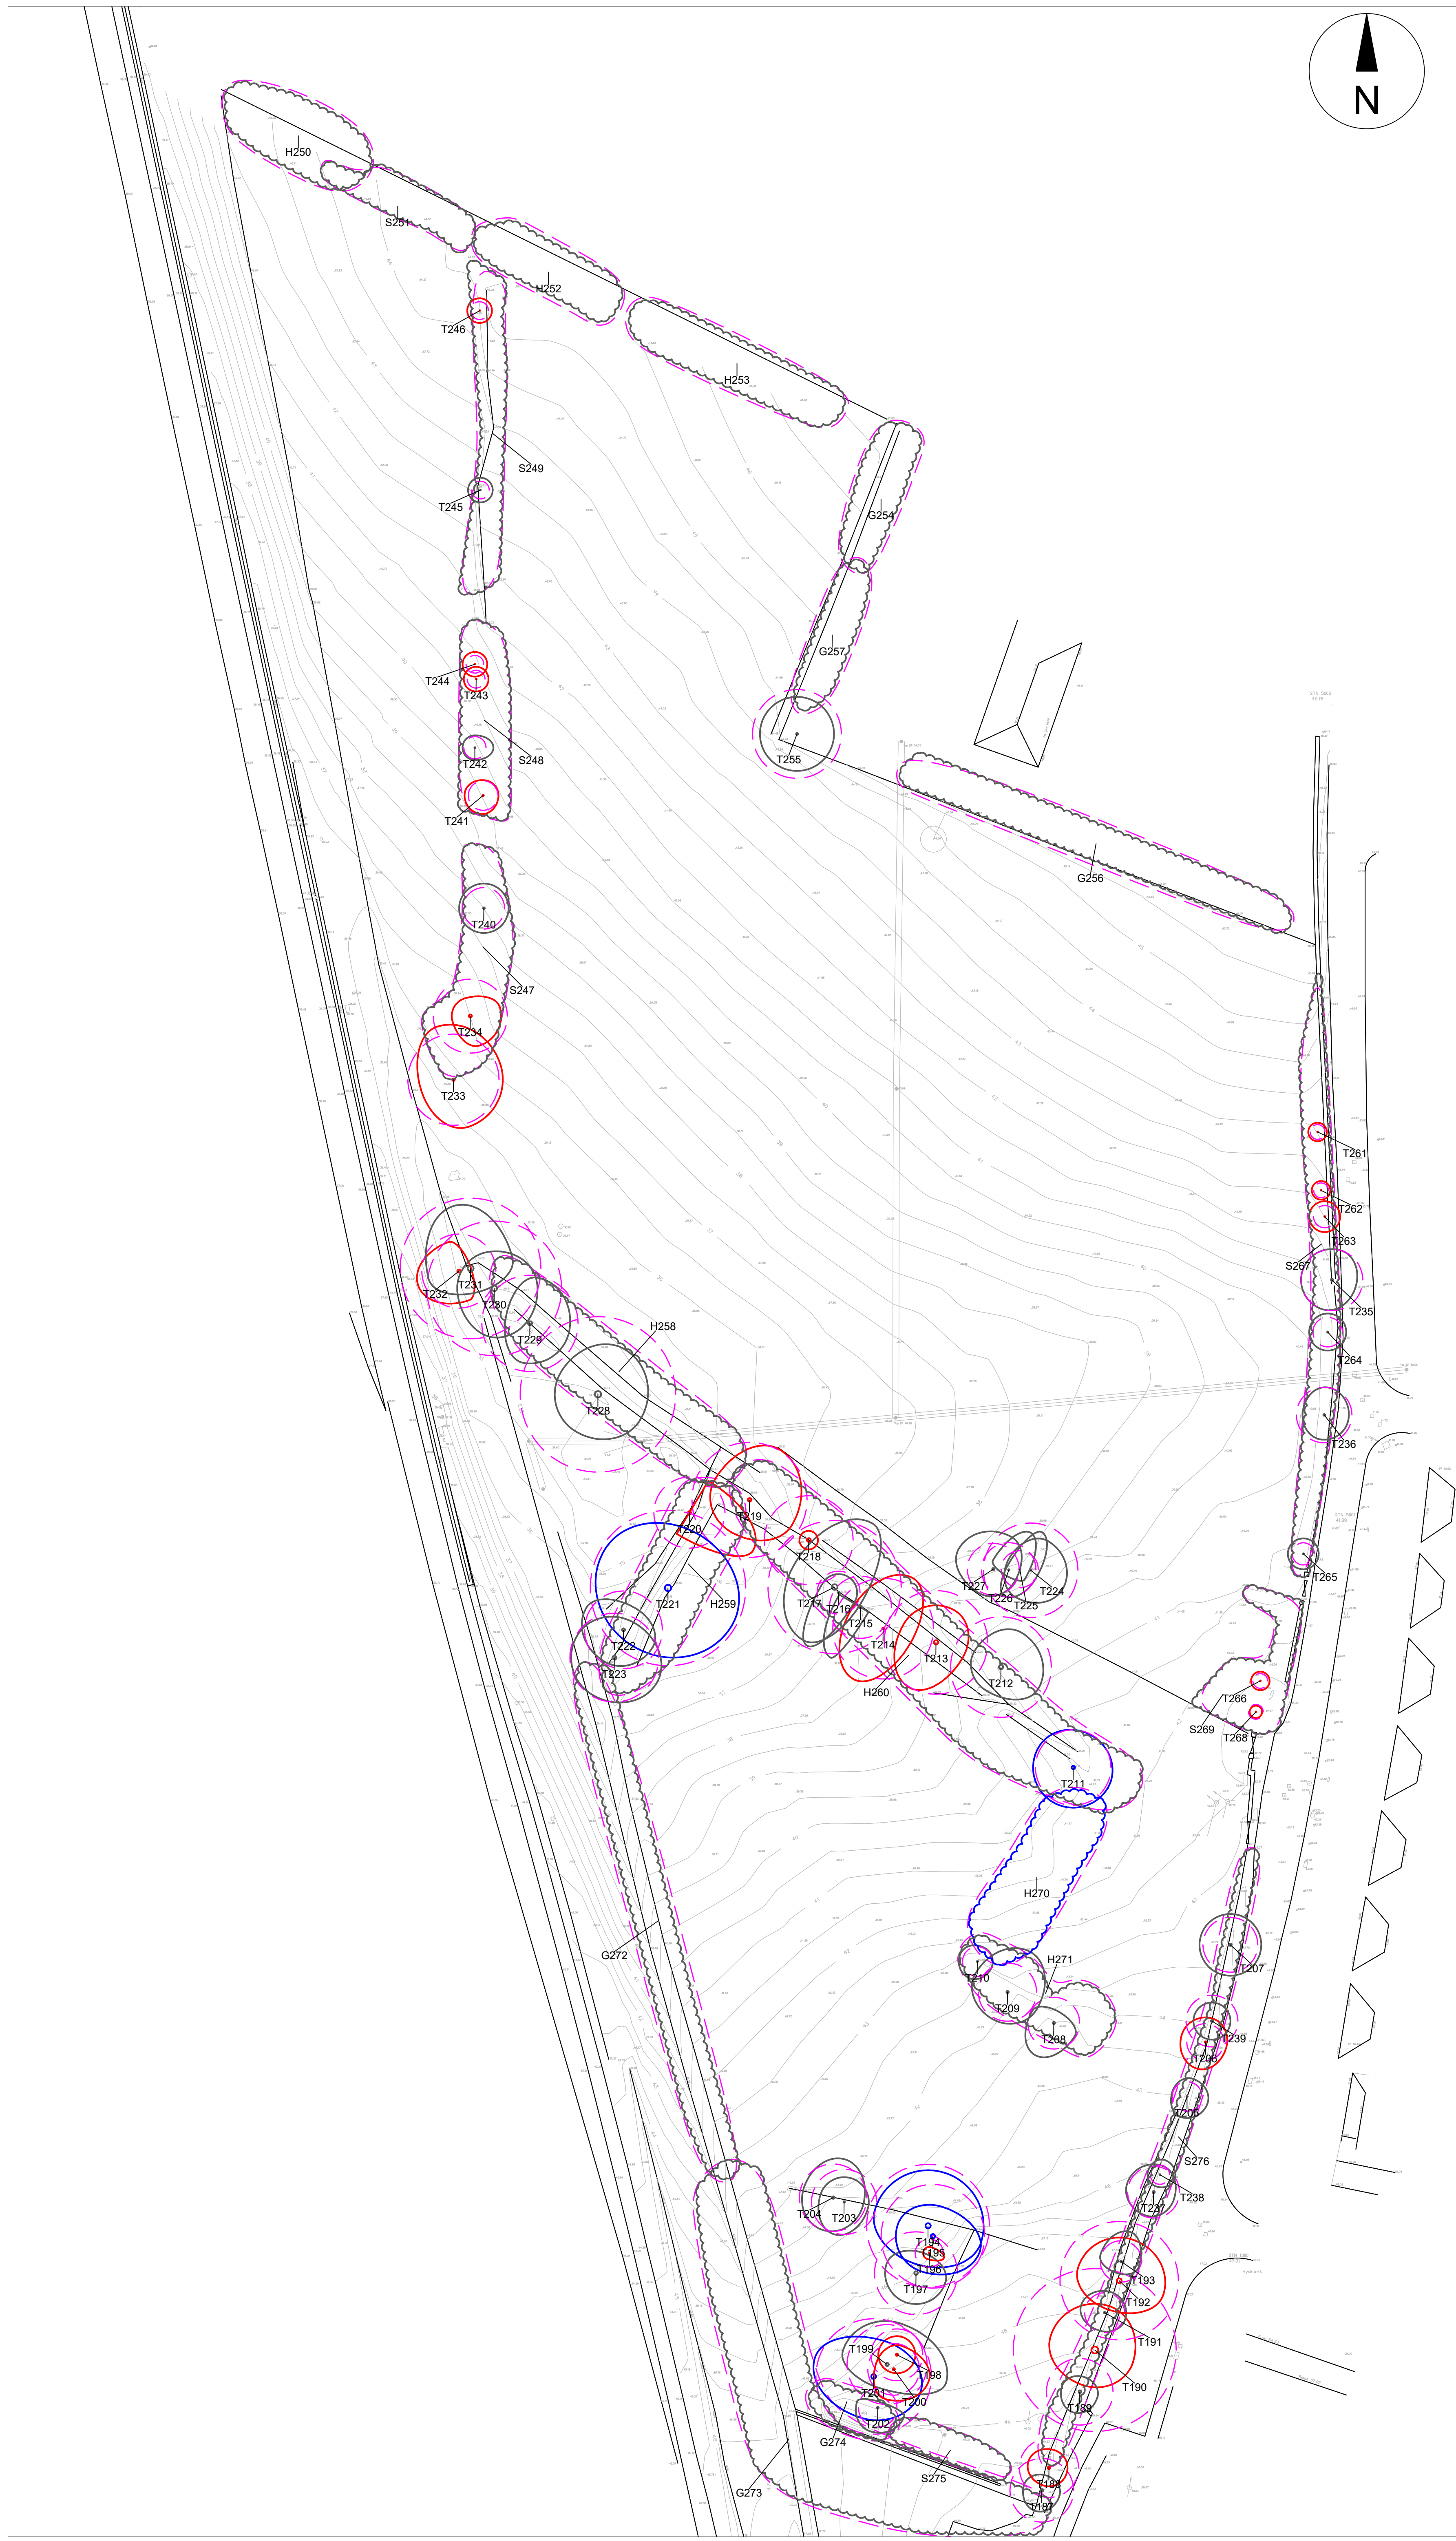
This drawing is to be read in conjunction with the respective arboricultural schedules and reports relevant to this project.

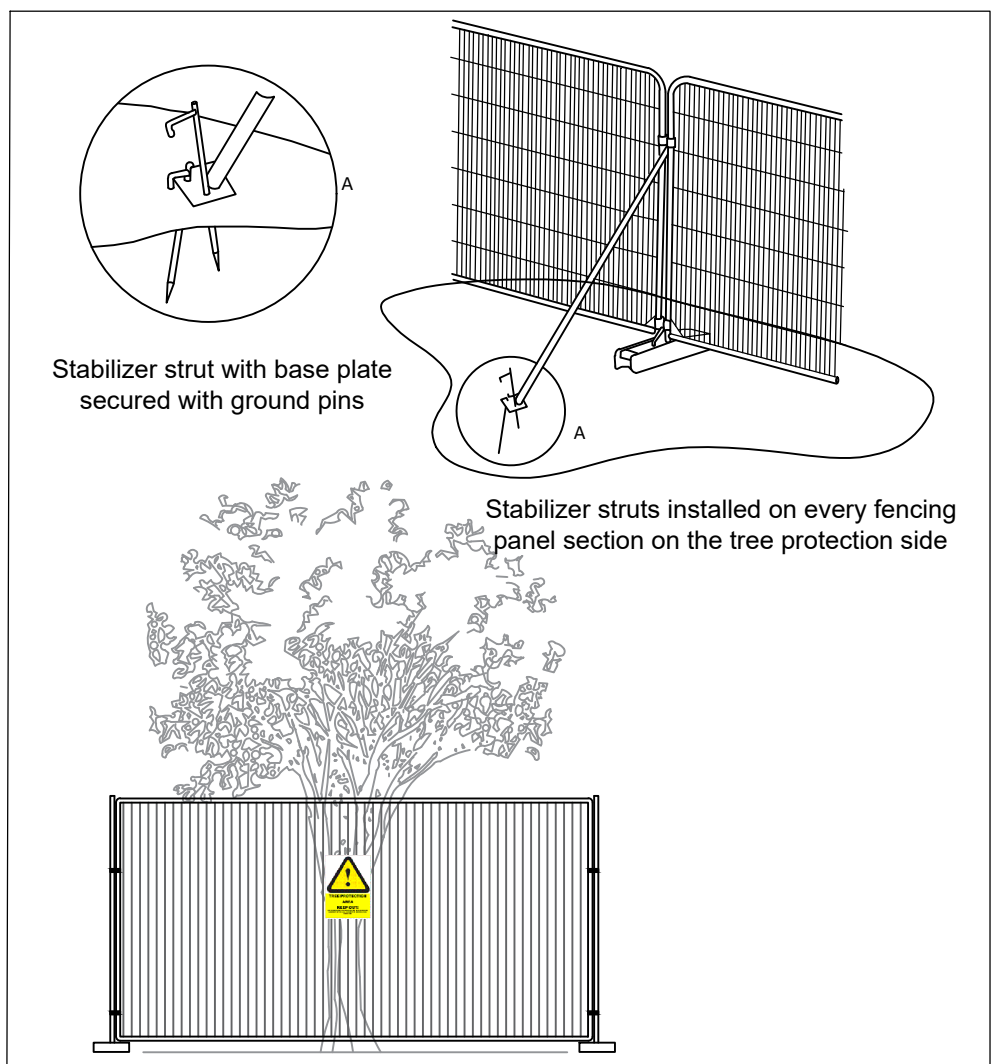
BS5837:2012 Figure 3

#### Tree Protection Specification - Above ground stabilizing system

- 6.13 **Tree protection measures** – Retained trees can be protected during the proposed development works by using robust fencing measures which comply with the recommendations outlined within BS 5837:2012. The location and specification of tree protection measures are highlighted in the Tree Protection Plan at Appendix B.
